**Mountain View
Whisman
School District**

ROOF ASSESSMENTS

Western Roofing Service

Benjamin Bubbs ES
 525 Hans Ave.
 Mountain View, CA 94040

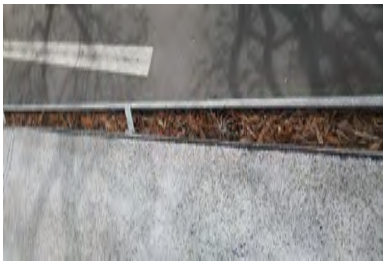
Typical Deficiency - Gutters are full of debris. Recommend clearing debris from all gutters, drains, waterways, and field of roof to promote positive drainage.

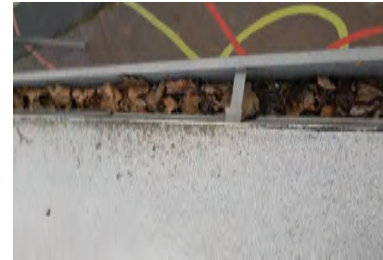
Typical Deficiency - Gutters are full of debris. Recommend clearing debris from all gutters, drains, waterways, and field of roof to promote positive drainage.

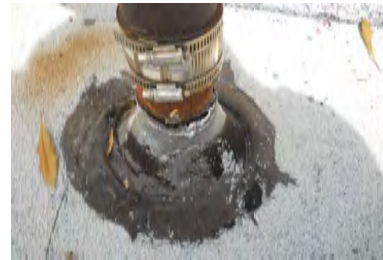
Typical Deficiency - Through roof penetrations do not appear to have proper low slope roof jack. Recommend installing proper roof jack and storm collar.

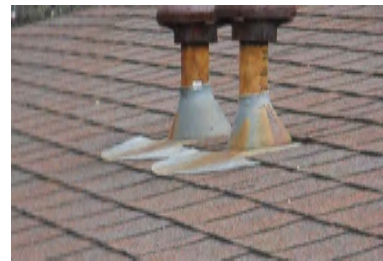
Typical Deficiency - Pipe jacks are missing band clamps and sealant. Recommend installing stainless steel band clamps, sealant, and install storm collar.

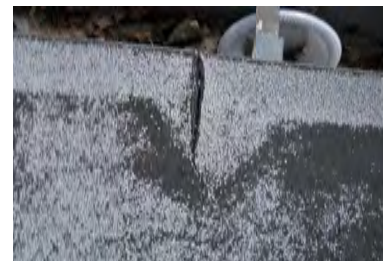
Typical Deficiency - BUR at gravel stop edge metal has split at joints. Recommend removing loose material to expose adequate tie-in of existing striping plies, prime and re-flash per industry standards.

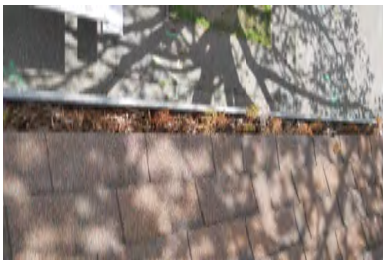
Typical Deficiency - Gutters are full of debris. Recommend clearing debris from all gutters, drains, waterways, and field of roof to promote positive drainage.

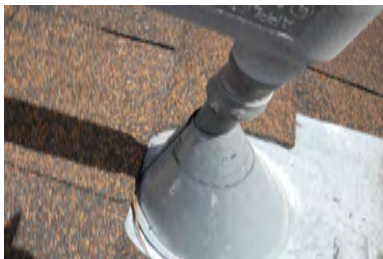
Typical Deficiency - Pipe jacks are missing sealant and or flexible self- adhered flashing tape. Recommend sealing, and install storm collar.

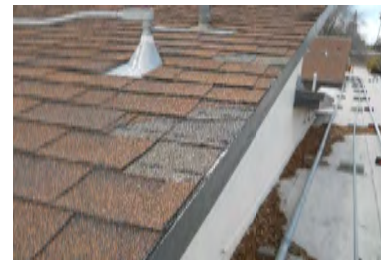
Typical Deficiency - Shingles are missing. Recommend replacing as needed.

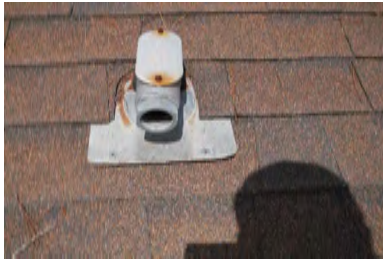
Typical Deficiency - Pipe jack is in need of replacement. Recommend installing new roof jack and storm collar. Recommend LB to be removed if abandoned.

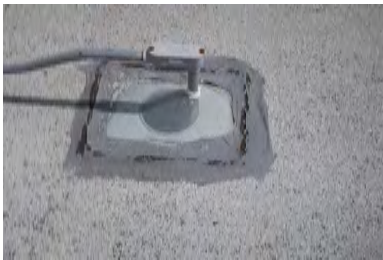
Typical Deficiency - Conduit penetrations do not appear to have proper roof jack. Recommend installing proper roof jack and storm collar.

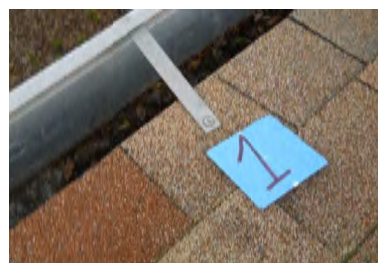
Typical Deficiency - Gutter brackets have been face fastened through asphalt shingle. Recommend removal and repositioning bracket. Repair asphalt shingles as needed.

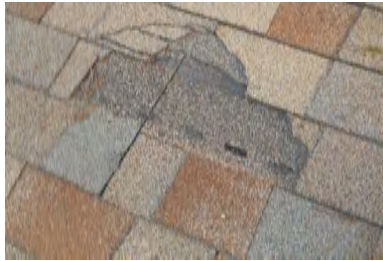
Typical Deficiency - Asphalt shingles are damaged and missing. Recommend replacing as needed.

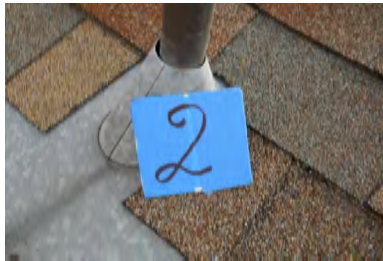
Typical Deficiency - Pipe jacks are missing sealant. Recommend application of flexible flashing self-adhered tape and or sealant, and install storm collar.

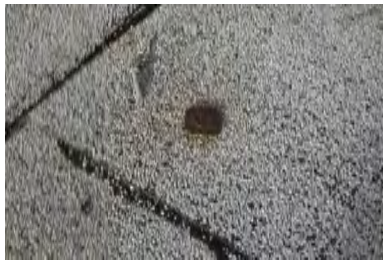
Typical Deficiency - Observed fastener penetrating through finished built-up roofing. Recommend removal and patch.

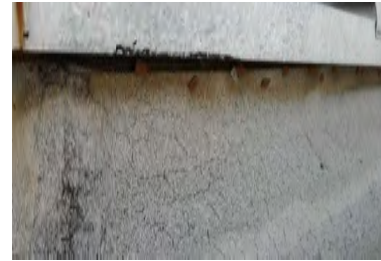
Typical Deficiency - Base flashing at mechanical curb has not been properly skirt flashed. Recommend installation of GSM skirt flashing.

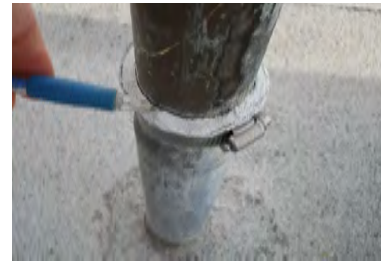
Typical Deficiency - Sealant at lead pipe jacks has begun to pull away from through roof penetration. Recommend replacing sealant as needed, installing stainless steel band clamps, and storm collar.

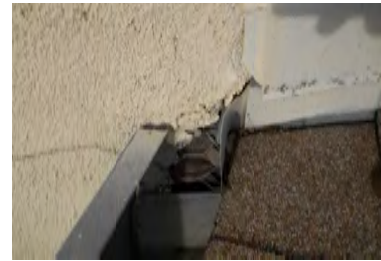
Typical Deficiency - Observed exposed lath and underlayment at roof to wall transition. Recommend stucco patch and as needed sealing to protect underlayment and minimize water intrusion behind stucco.

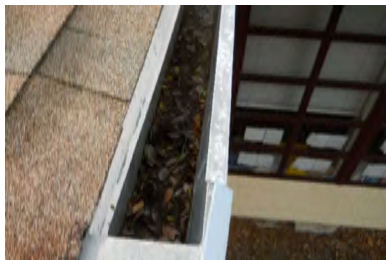
Typical Deficiency - Gutters are full of debris. Recommend clearing debris from all gutters, drains, waterways, and field of roof to promote positive drainage.

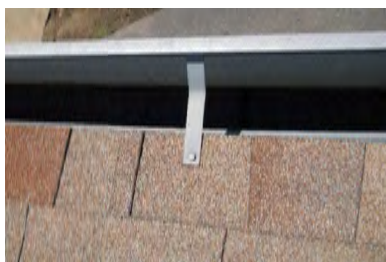
Typical Deficiency - Gutter brackets have been face fastened through asphalt shingle. Recommend removal and repositioning bracket. Repair asphalt shingles as needed.

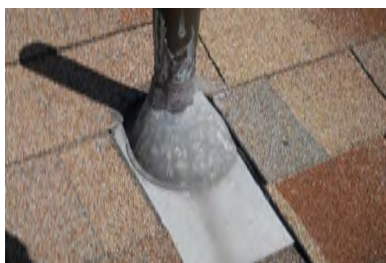
Typical Deficiency - Pipe jacks are missing sealant. Recommend application of flexible flashing self-adhered tape and or sealant, and install storm collar.

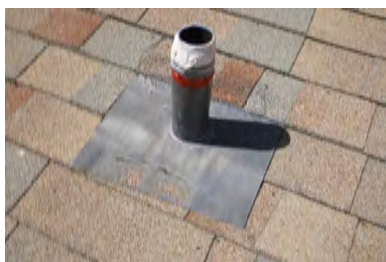
Typical Deficiency - Through roof penetration does not appear to have proper roof jack. Recommend installing proper roof jack and storm collar.

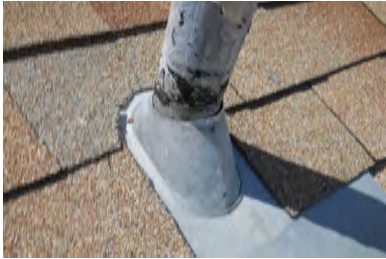
Typical Deficiency - Pipe jacks are missing sealant. Recommend application of flexible flashing self-adhered tape and or sealant, and install storm collar.

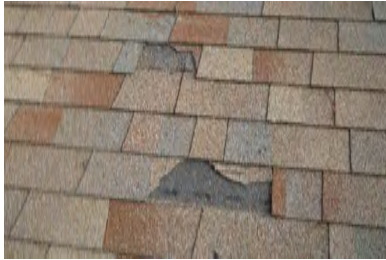
Typical Deficiency - Asphalt shingles are damaged and missing. Recommend replacing as needed.

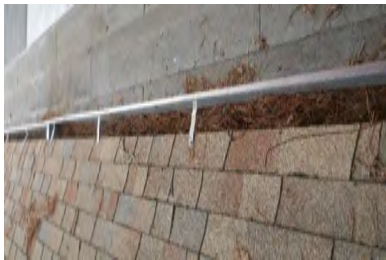
Typical Deficiency - Gutter brackets have been face fastened through asphalt shingle. Recommend removal and repositioning bracket. Repair asphalt shingles as needed.
Typical Deficiency - Gutters are full of debris. Recommend clearing debris from all gutters, drains, waterways, and field of roof to promote positive drainage.

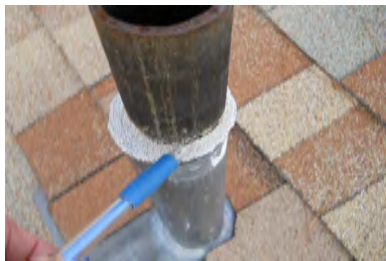
Typical Deficiency - Pipe jack sealant has begun to pull away from through roof pipe penetration. Recommend application of flexible flashing self-adhered tape and or sealant, and install storm collar.

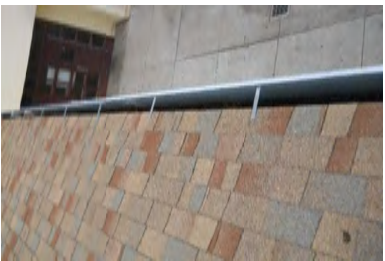
Typical Deficiency - Gutter brackets have been face fastened through asphalt shingle. Recommend removal and repositioning bracket. Repair asphalt shingles as needed.

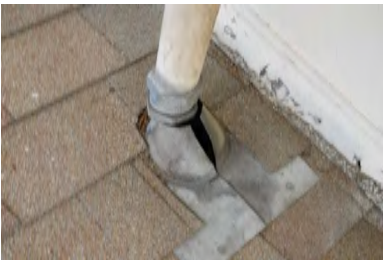
Typical Deficiency - Pipe jack is open. Recommend removal and replacement and installation of storm collar.

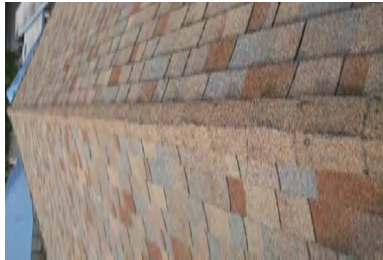
Typical Deficiency - Hip and ridge shingles are damaged and missing. Recommend replacing as needed.

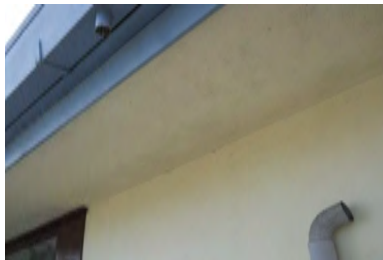
Typical Deficiency - Missing leader pipe. Recommend installation of leader pipe to divert water to lower roof.

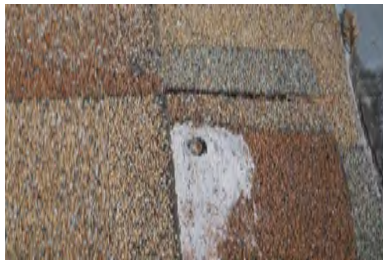
Typical Deficiency - Observed fastener penetrating through finished asphalt shingle roofing. Recommend removal and repair as needed.

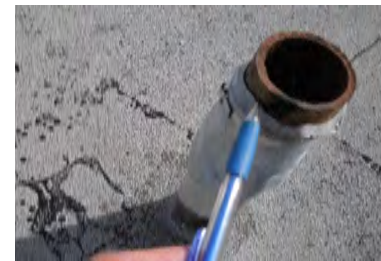
Typical Deficiency - Sealant at low slope roof jack needs to be replaced. Recommend re-seal and install storm collar.

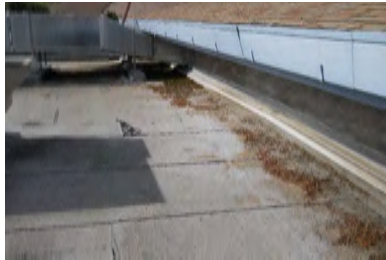
Typical Deficiency - Observed accumulation of debris at field of roof. Recommend clearing debris from all gutters, drains, waterways, and field of roof to promote positive drainage.

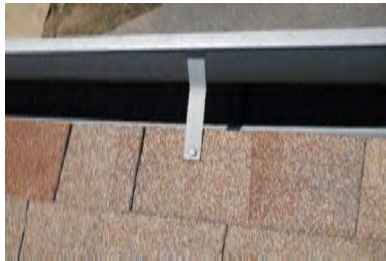
Typical Deficiency - Gutter brackets have been face fastened through asphalt shingle. Recommend removal and repositioning bracket. Repair asphalt shingles as needed.

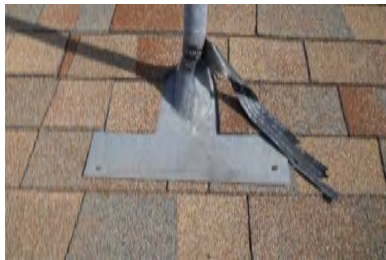
Typical Deficiency - Sealant at steep slope roof jack needs to be replaced. Recommend re-seal and install storm collar.

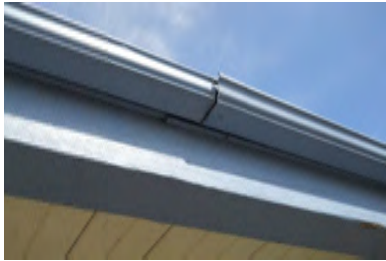
Typical Deficiency - Damaged gutter seam.
Recommend repair as needed.

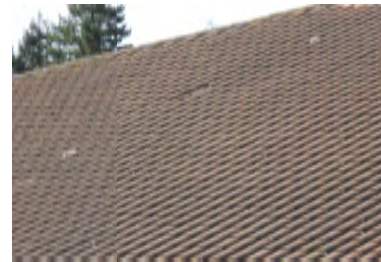
Typical Deficiency - Missing concrete S tile.
Recommend replacement of all missing and
or damaged tiles.

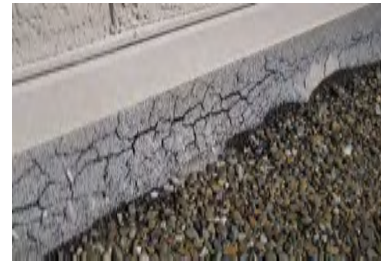
Typical Deficiency - Base flashings show signs
of deterioration and cracking. Recommend
application of silicone or acrylic coating to
maximize usable life of existing built-up roof
system.

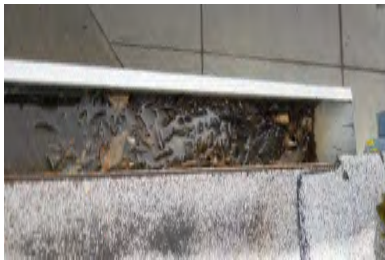
Typical Deficiency - Gutters are full of debris. Recommend clearing debris from all gutters, drains, waterways, and field of roof to promote positive drainage.

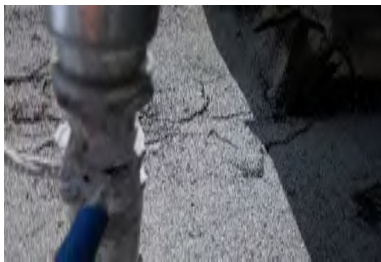
Typical Deficiency - Pipe jacks are missing sealant. Recommend application of flexible flashing self-adhered tape and or sealant, and install storm collar.

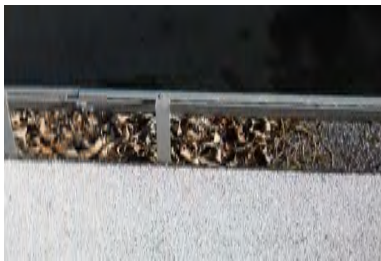
Typical Deficiency - Gutters are full of debris. Recommend clearing debris from all gutters, drains, waterways, and field of roof to promote positive drainage.

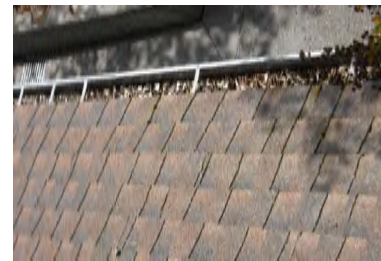
Typical Deficiency - Gutters are full of debris. Recommend clearing debris from all gutters, drains, waterways, and field of roof to promote positive drainage.

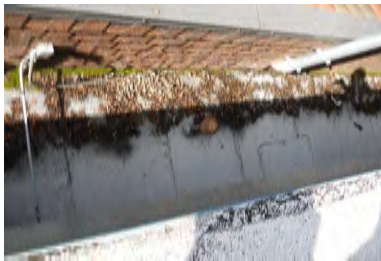
Typical Deficiency - Observed accumulation of debris at field of roof. Recommend clearing debris from all gutters, drains, waterways, and field of roof to promote positive drainage.

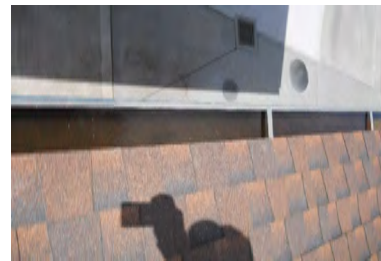
Typical Deficiency - Missing drop outlet and leader pipe. Recommend installation of drop outlet and leader pipe for drainage.

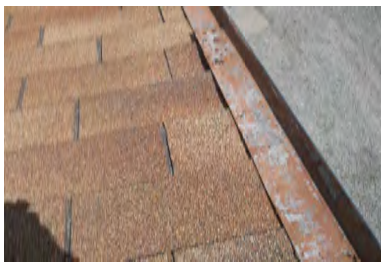
Typical Deficiency - Edge metal has been fastened directly through existing shingle roofing. Recommend metal removal, replacement, and roof repairs as needed.

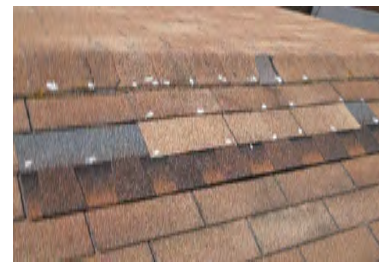
Typical Deficiency - Asphalt shingles are damaged and missing. Recommend replacing as needed.
