# Mountain View Whisman School District

## Roof Assessment

**Edith Landels ES**  
 115 West Dana St.  
 Mountain View, CA 94041

**Prepared By:**  
 Western Roofing Service  
 15002 Wicks Blvd.  
 San Leandro, CA 94577

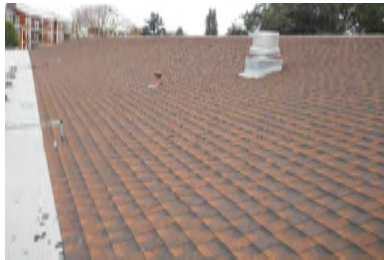
Typical Deficiency - LB electrical penetrations have not been flashed properly. Recommend installing galvanized pitch pocket with cover.

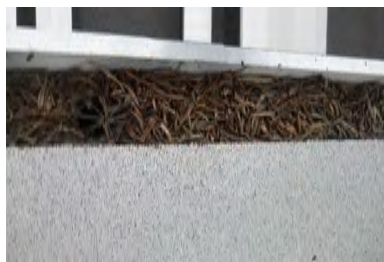
Typical Deficiency - Gutters are full of debris. Recommend clearing debris from all gutters, drains, waterways, and field of roof to promote positive drainage.

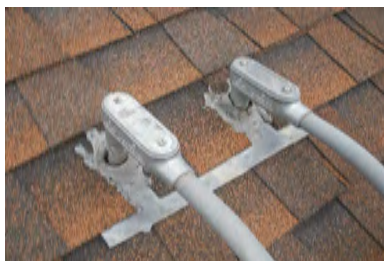
Typical Deficiency - Through roof penetrations do not appear to have proper roof jack. Recommend installing proper roof jack and storm collar.

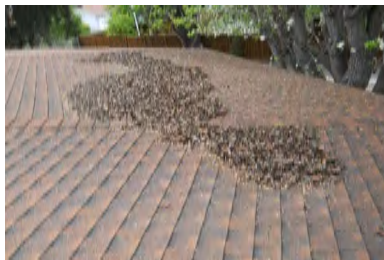
Typical Deficiency - Debris have accumulated on roofs. Recommend clearing debris from all gutters, drains, waterways, and field of roof to promote positive drainage.

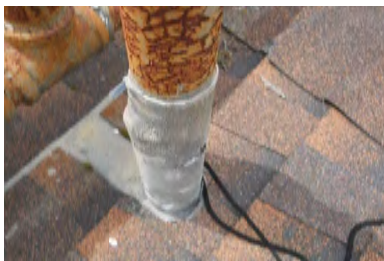
Typical Deficiency - Pipe jacks are missing band clamps and sealant. Recommend installing stainless steel band clamps, apply sealant, and install storm collar.

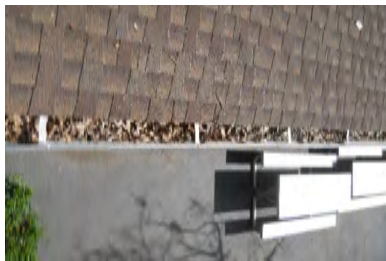
Typical Deficiency - Gutters are full of debris. Recommend clearing debris from all gutters, drains, waterways, and field of roof to promote positive drainage.

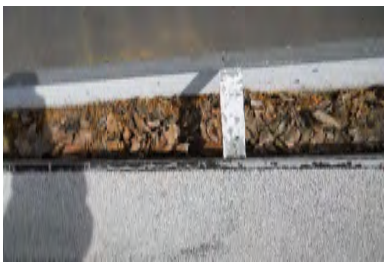
Typical Deficiency - Gutters are full of debris. Recommend clearing debris from all gutters, drains, waterways, and field of roof to promote positive drainage.

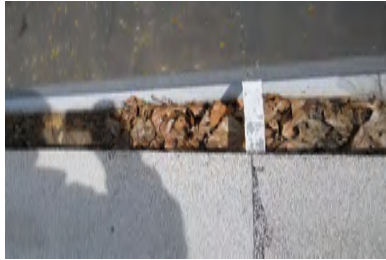
Typical Deficiency - Gutters are full of debris. Recommend clearing debris from all gutters, drains, waterways, and field of roof to promote positive drainage.

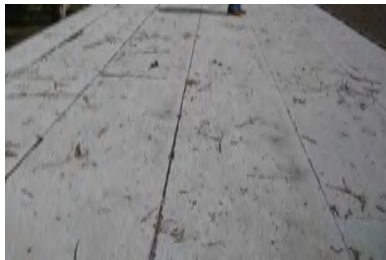
Typical Deficiency - Observed debris at field of roofing. Recommend clearing debris from all gutters, drains, waterways, and field of roof to promote positive drainage.

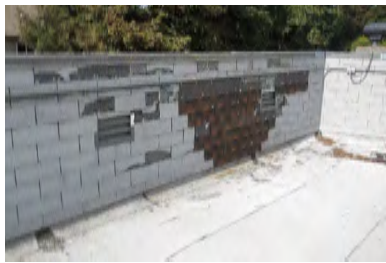
Typical Deficiency - Asphalt shingles are damaged and missing. Recommend replacing.

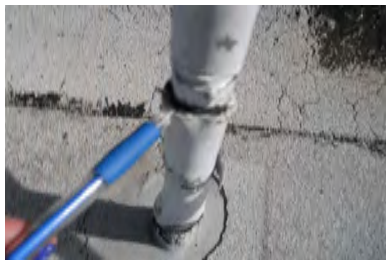
Typical Deficiency - Through roof penetration has not been properly sealed. Recommend re-sealing and installing storm collar.

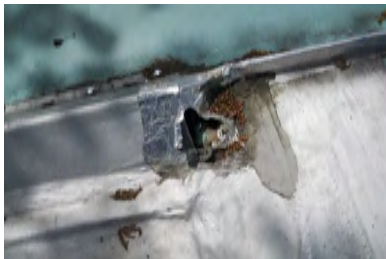
Typical Deficiency - Roof transition is open.  
Recommend removal of all temporary repairs and installation of as needed permanent repairs.

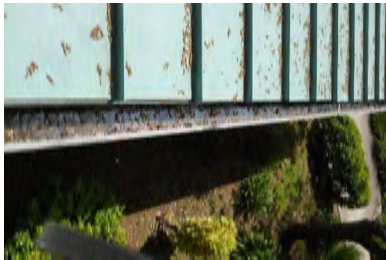
Typical Deficiency - Gutters are full of debris. Recommend clearing debris from all gutters, drains, waterways, and field of roof to promote positive drainage.

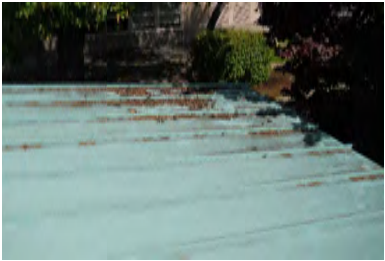
Typical Deficiency - Debris have accumulated at field of roof. Recommend clearing debris from all gutters, drains, waterways, and field of roof to promote positive drainage.

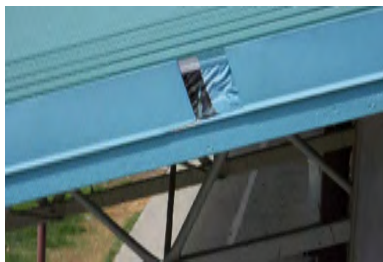
Typical Deficiency - Metal fascia detail is incomplete. Recommend repairing as necessary to provide a water tight application.

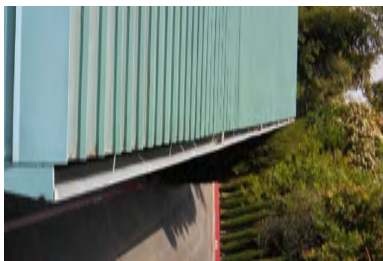
Typical Deficiency - Gutters are full of debris. Recommend clearing debris from all gutters, drains, waterways, and field of roof to promote positive drainage.

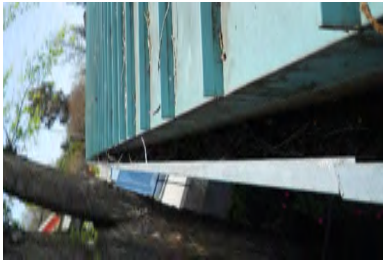
Typical Deficiency - Gutters are full of debris. Recommend clearing debris from all gutters, drains, waterways, and field of roof to promote positive drainage.

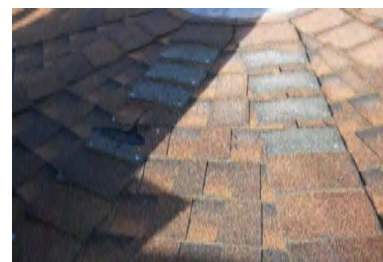
Typical Deficiency - Hip and ridge shingles are missing. Recommend replacing as needed.

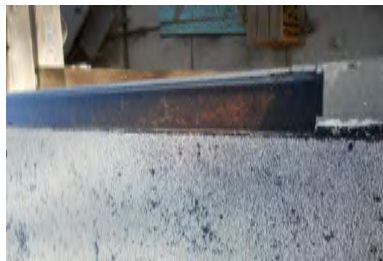
Typical Deficiency - Gutters are full of debris. Recommend clearing debris from all gutters, drains, waterways, and field of roof to promote positive drainage.

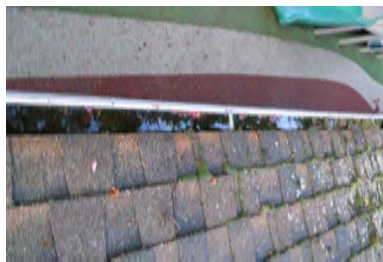
Typical Deficiency - Gutters are full of debris. Recommend clearing debris from all gutters, drains, waterways, and field of roof to promote positive drainage.

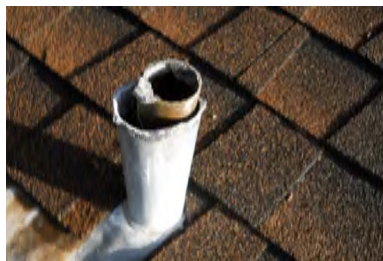
Typical Deficiency - Pipe jacks are missing band clamps and sealant. Recommend installing stainless steel band clamps, apply sealant, and install storm collar.

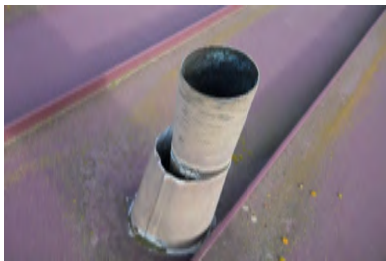
Typical Deficiency - Pipe jacks are missing sealant. Recommend application of flexible flashing self-adhered tape and or sealant, and install storm collar.

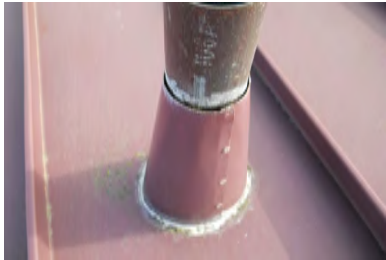
Typical Deficiency - Pipe jacks are missing sealant. Recommend application of flexible flashing self-adhered tape and or sealant, and install storm collar.

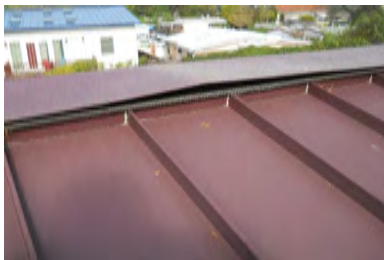
Typical Deficiency - Ridge cap has buckled. Recommend removal and reinstallation incorporating an expansion plate for movement.

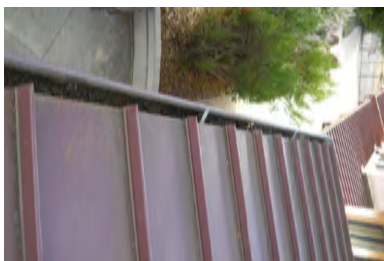
Typical Deficiency - Gutters are full of debris. Recommend clearing debris from all gutters, drains, waterways, and field of roof to promote positive drainage.

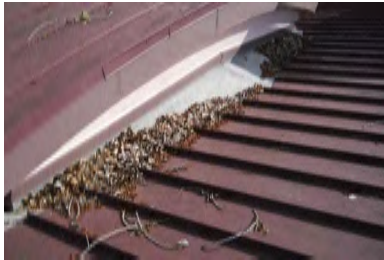
Typical Deficiency - Debris have accumulated at field of roof. Recommend clearing debris from all gutters, drains, waterways, and field of roof to promote positive drainage.

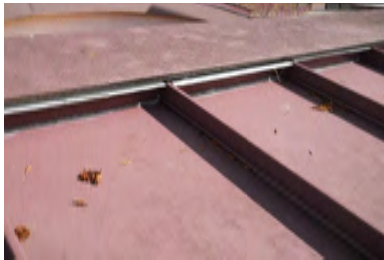
Typical Deficiency - Ridge closure pieces have buckled. Recommend removal and reinstallation as needed.

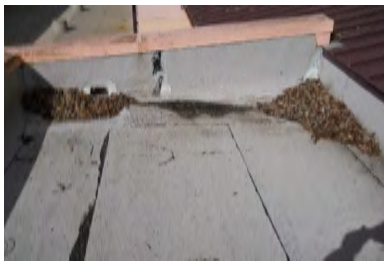
Typical Deficiency - Debris have accumulated at field of roof. Recommend clearing debris from all gutters, drains, waterways, and field of roof to promote positive drainage. Through wall scuppers should have debris screens. Recommend installation of gutter screens to promote positive drainage.

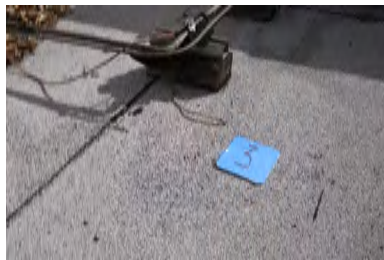
Typical Deficiency - Mineral surfaced cap sheet has blistered. Recommend relief cutting blister, imbed in layer of modified mastic, and apply target sheet of mineral surfaced cap sheet in cold applied adhesive.

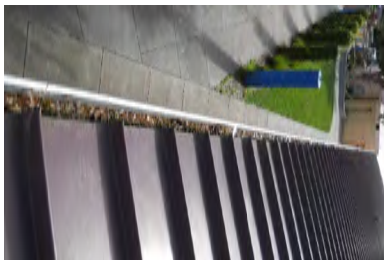
Typical Deficiency - Gutters are full of debris. Recommend clearing debris from all gutters, drains, waterways, and field of roof to promote positive drainage.

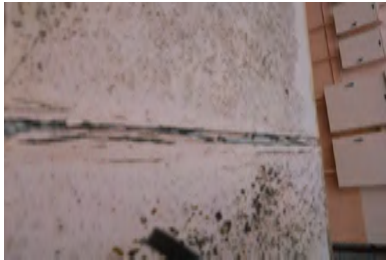
Typical Deficiency - Sealant at coping seams has begun to fail. Recommend removal and replacement of sealant as needed.

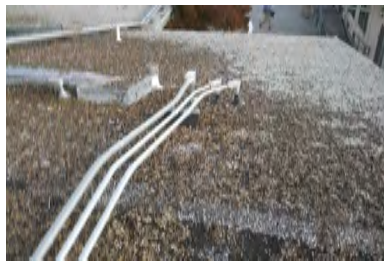
Typical Deficiency - Debris have accumulated at field of roof. Recommend clearing debris from all gutters, drains, waterways, and field of roof to promote positive drainage.

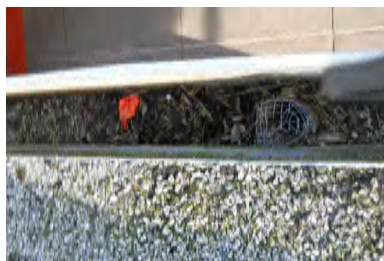
Typical Deficiency - Gutters are full of debris. Recommend clearing debris from all gutters, drains, waterways, and field of roof to promote positive drainage.

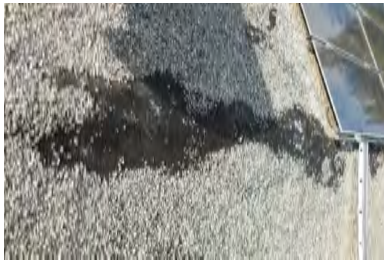
Typical Deficiency - Areas of displaced gravel. Recommend re-distributing and adhering gravel over bare areas to protect underlying membrane from exposure to UV .

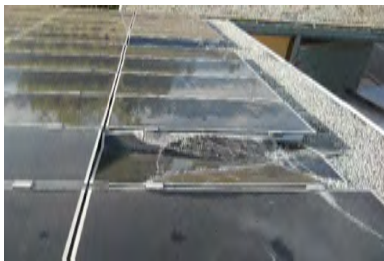
Typical Deficiency - Damaged solar panels. Recommend further investigation and repair by licensed solar contractor.

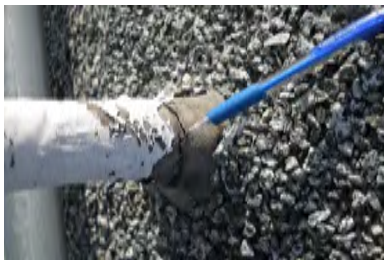
Typical Deficiency - Detailing at through roof penetrations show signs of cracking and delamination. Recommend touch up of mastic at penetrations and application of acrylic or silicone coating to preserve and maintain repair.

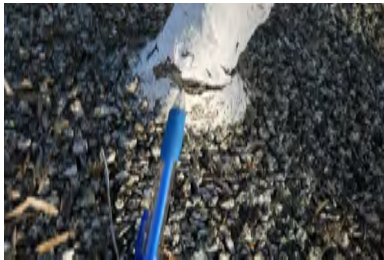
Typical Deficiency - Detailing at through roof penetrations show signs of cracking and delamination. Recommend touch up of mastic at penetrations and application of acrylic or silicone coating to preserve and maintain repair.

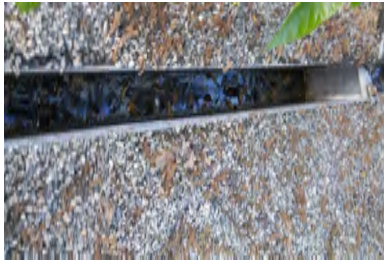
Typical Deficiency - Gutters are full of debris. Recommend clearing debris from all gutters, drains, waterways, and field of roof to promote positive drainage.

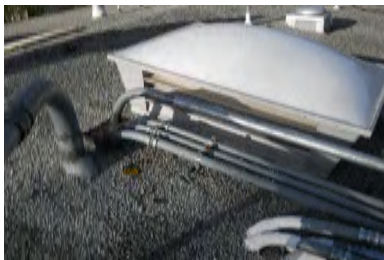
Leak Reported Below. Recommend further review and assessment.

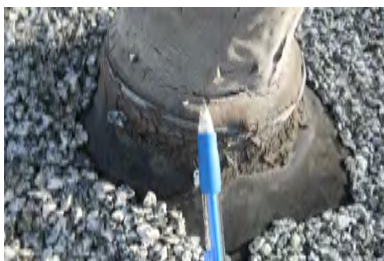
Typical Deficiency - Detailing at through roof penetrations show signs of cracking and delamination. Recommend touch up of mastic at penetrations and application of acrylic or silicone coating to preserve and maintain repair.

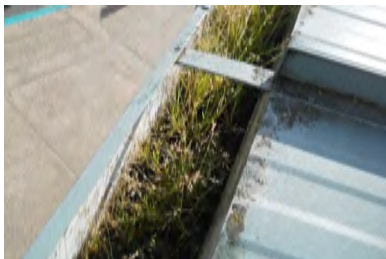
Typical Deficiency - Gutters are full of debris. Recommend clearing debris from all gutters, drains, waterways, and field of roof to promote positive drainage.

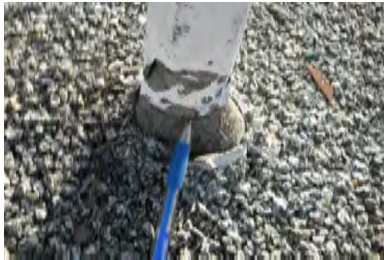
Typical Deficiency - Detailing at through roof penetrations show signs of cracking and delamination. Recommend touch up of mastic at penetrations and application of acrylic or silicone coating to preserve and maintain repair.
