**Mountain View
Whisman
School District**

ROOF ASSESSMENTS

Western Roofing Service

Mountain View Whisman School District Roof Assessment

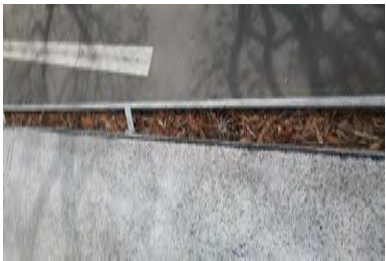
Typical Deficiency - Gutters are full of debris. Recommend clearing debris from all gutters, drains, waterways, and field of roof to promote positive drainage.

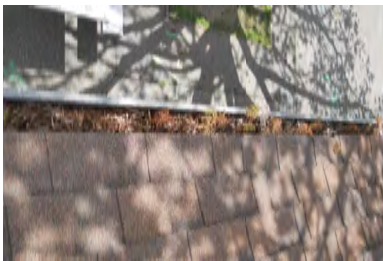
Typical Deficiency - Gutters are full of debris. Recommend clearing debris from all gutters, drains, waterways, and field of roof to promote positive drainage.

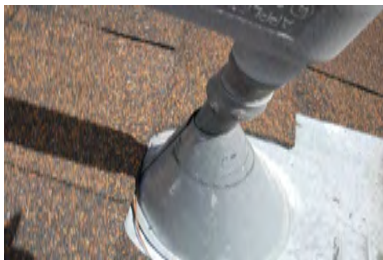
Typical Deficiency - Pipe jacks are missing sealant and or flexible self-adhered flashing tape. Recommend sealing, and install storm collar.

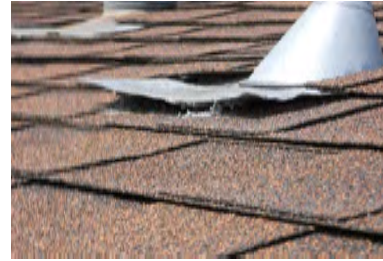
Typical Deficiency - Pipe jacks are damaged. Recommend installing new GSM roof jack and storm collar.

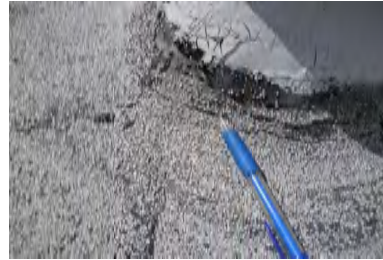
Typical Deficiency - Detailing at through roof penetrations show signs of cracking and delamination. Recommend touch up of mastic at penetrations and application of acrylic or silicone coating to preserve and maintain repair.

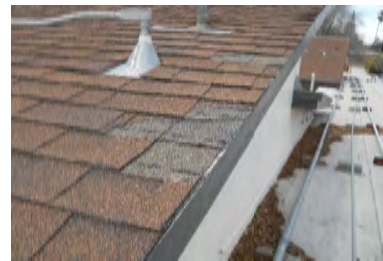
Typical Deficiency - Shingles are missing. Recommend replacing as needed.

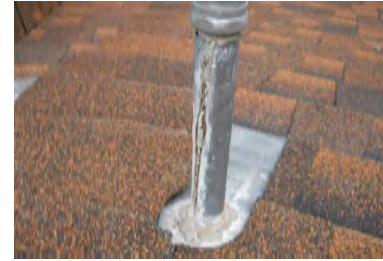
Typical Deficiency - Pipe jacks are missing band clamps and sealant. Recommend installing stainless steel band clamps, apply sealant, and install storm collar.

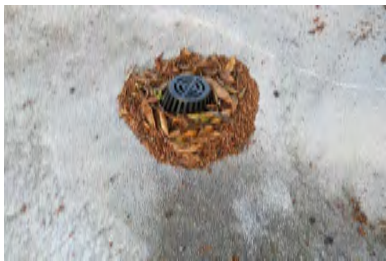
Typical Deficiency - Debris have accumulated at field of roof. Recommend clearing debris from all gutters, drains, waterways, and field of roof to promote positive drainage.

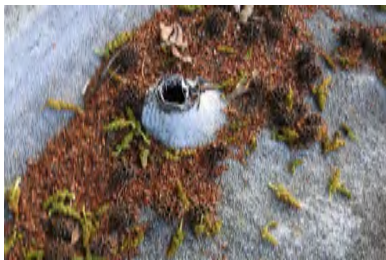
Typical Deficiency - Pipe jack at through roof penetration is damaged. Recommend repairing as needed.

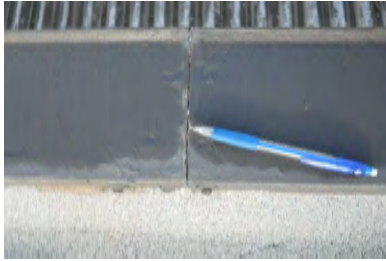
Typical Deficiency - Sealant at coping seams has begun to fail. Recommend removal and replacement of sealant as needed.

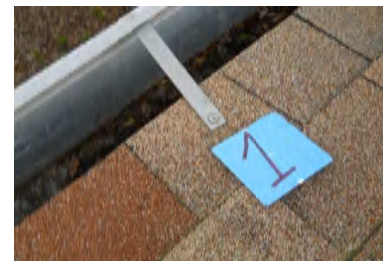
Typical Deficiency - Gutter brackets have been face fastened through asphalt shingle. Recommend removal and repositioning bracket. Repair asphalt shingles as needed.

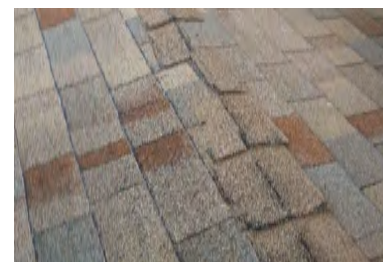
Typical Deficiency - Hip and ridge shingles are damaged and missing. Recommend replacing as needed.

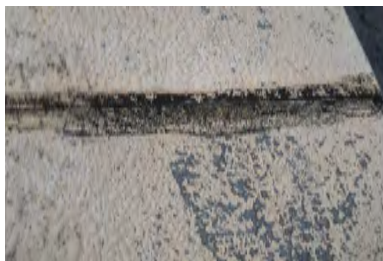
Typical Deficiency - Sealant at coping seams has begun to fail. Recommend removal and replacement of sealant as needed.

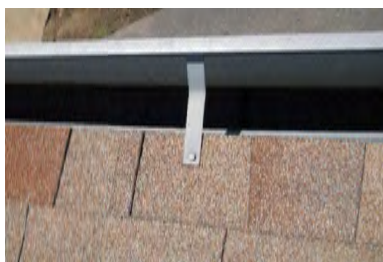
Typical Deficiency - Gutter brackets have been face fastened through asphalt shingle. Recommend removal and repositioning bracket. Repair asphalt shingles as needed.

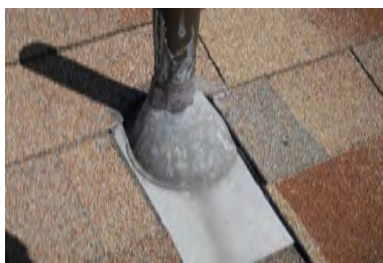
Typical Deficiency - Pipe jacks are missing sealant. Recommend application of flexible flashing self-adhered tape and or sealant, and install storm collar.

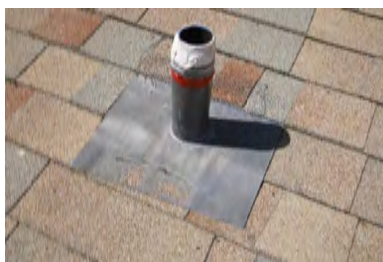
Typical Deficiency - Through roof penetration does not appear to have proper roof jack. Recommend installing proper roof jack and storm collar.

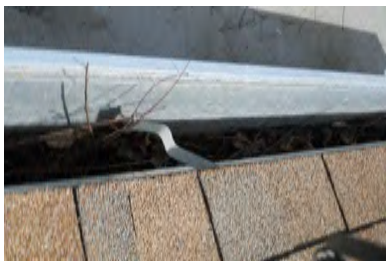
Typical Deficiency - Gutter straps need to be re-fastened.

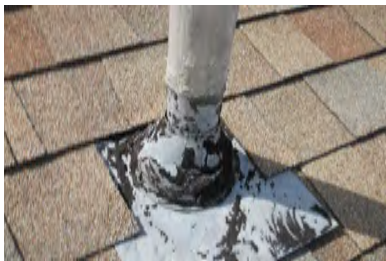
Typical Deficiency - Pipe jacks are missing sealant. Recommend application of flexible flashing self-adhered tape and or sealant, and install storm collar.

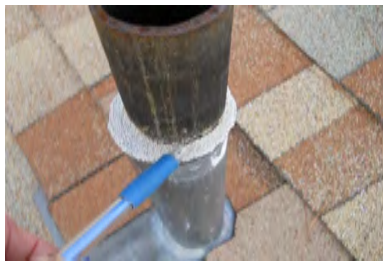
Typical Deficiency - Pipe jack sealant has begun to pull away from through roof pipe penetration. Recommend application of flexible flashing self-adhered tape and sealant, and install storm collar.

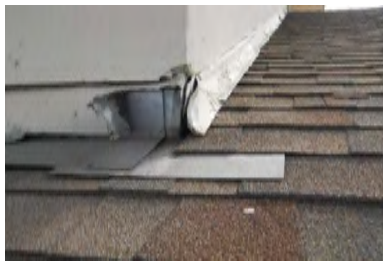
Typical Deficiency - Roof to wall counter flashing is open. Recommend removal and replacement as necessary to achieve water tight application.

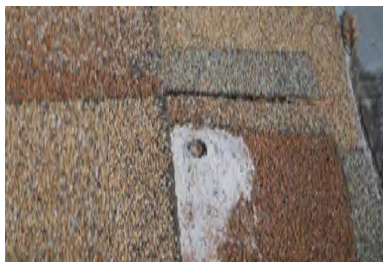
Typical Deficiency - Observed fastener penetrating through finished asphalt shingle roofing. Recommend removal and repair as needed.

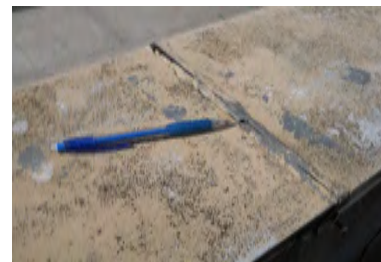
Typical Deficiency - Sealant at coping seams has begun to fail. Recommend removal and replacement of sealant as needed.

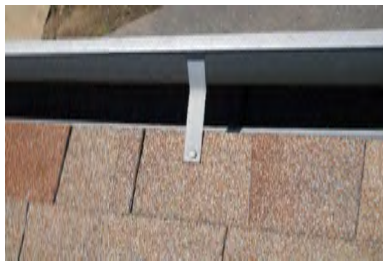
Typical Deficiency - Gutter brackets have been face fastened through asphalt shingle. Recommend removal and repositioning bracket. Repair asphalt shingles as needed.

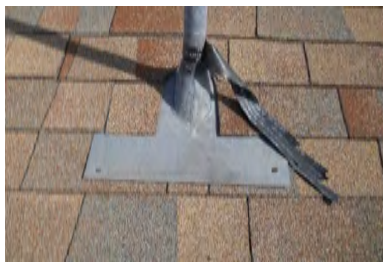
Typical Deficiency - Sealant at steep slope roof jack needs to be replaced. Recommend re-seal and install storm collar.

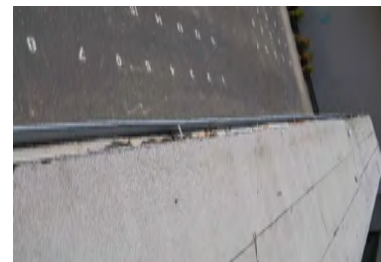
Typical Deficiency - Gutters are full of debris. Recommend clearing debris from all gutters, drains, waterways, and field of roof to promote positive drainage.

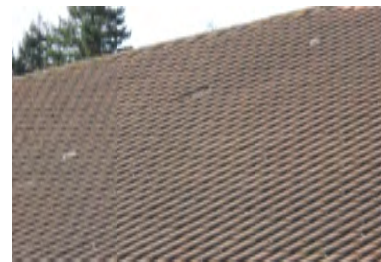
Typical Deficiency - Missing concrete S tile.
Recommend replacement of all missing and or damaged tiles.

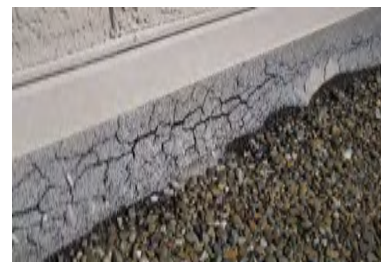
Typical Deficiency - Base flashings show signs of deterioration and cracking. Recommend application of silicone or acrylic coating to maximize usable life of existing built-up roof system.

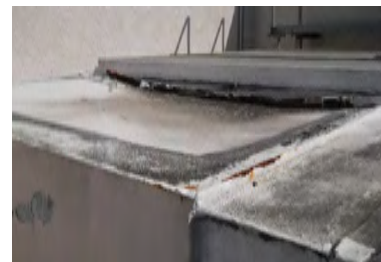
Typical Deficiency - Mechanical duct work damaged and deteriorated. Recommend replacement of damaged duct by licensed mechanical contractor and coating with acceptable silicone or acrylic coating.

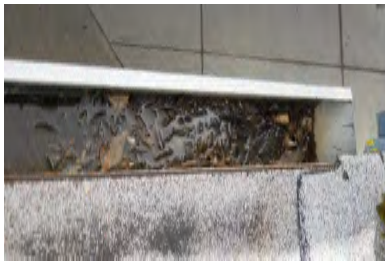
Typical Deficiency - Gutters are full of debris. Recommend clearing debris from all gutters, drains, waterways, and field of roof to promote positive drainage.

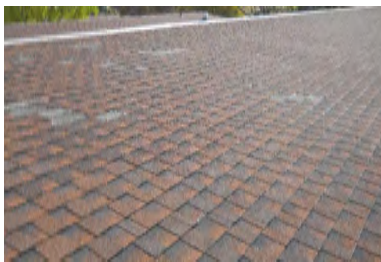
Typical Deficiency - Asphalt shingles are damaged and missing. Recommend replacing as needed.

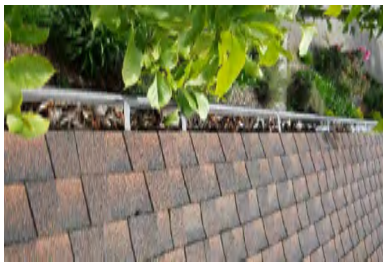
Typical Deficiency - Gutters are full of debris. Recommend clearing debris from all gutters, drains, waterways, and field of roof to promote positive drainage.

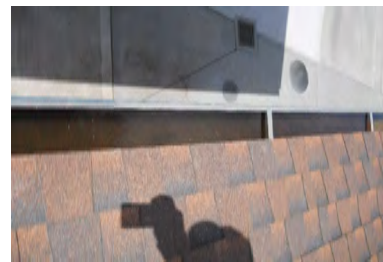
Typical Deficiency - Missing drop outlet and leader pipe. Recommend installation of drop outlet and leader pipe for drainage.

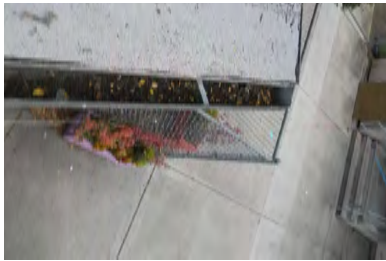
Typical Deficiency - Gutters are full of debris. Recommend clearing debris from all gutters, drains, waterways, and field of roof to promote positive drainage.

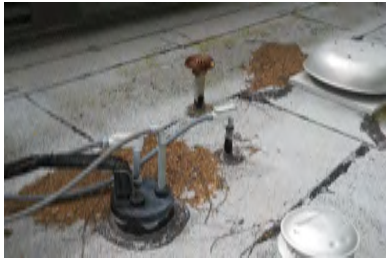
Typical Deficiency - Observed accumulation of debris at field of roof. Recommend clearing debris from all gutters, drains, waterways, and field of roof to promote positive drainage.

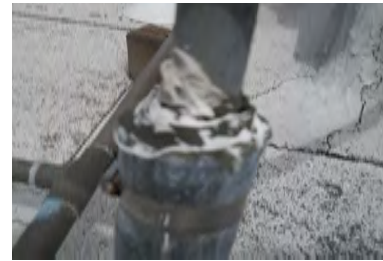
Typical Deficiency - Sealants at pipe jacks have dried up and pulled away. Recommend removal/ replacement of sealant, and install storm collar.

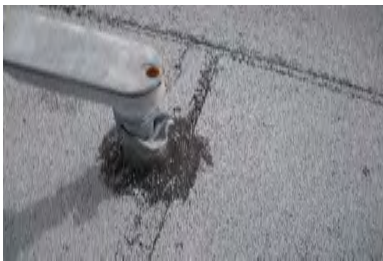
Typical Deficiency - Pipe jacks are missing band clamps and sealant. Recommend installing stainless steel band clamps, apply sealant, and install storm collar.

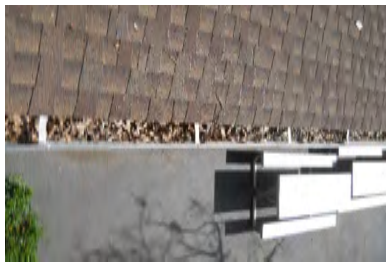
Typical Deficiency - Gutters are full of debris. Recommend clearing debris from all gutters, drains, waterways, and field of roof to promote positive drainage.

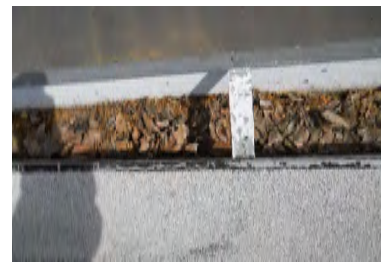
Typical Deficiency - Gutters are full of debris. Recommend clearing debris from all gutters, drains, waterways, and field of roof to promote positive drainage.

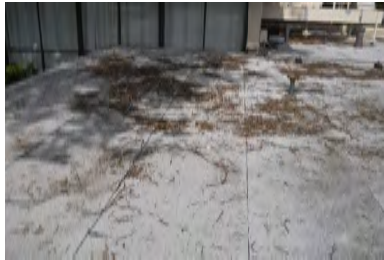
Typical Deficiency - Observed debris at field of roofing. Recommend clearing debris from all gutters, drains, waterways, and field of roof to promote positive drainage.

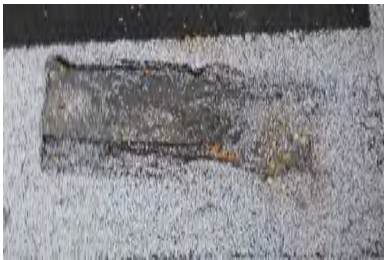
Typical Deficiency - Mineral surfaced cap sheet is damaged from previous sleeper block that has been removed. Recommend repairing as needed.

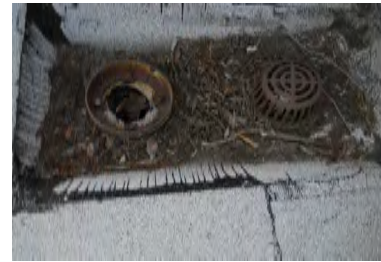
Typical Deficiency - Observed debris at field of roofing. Recommend clearing debris from all gutters, drains, waterways, and field of roof to promote positive drainage.

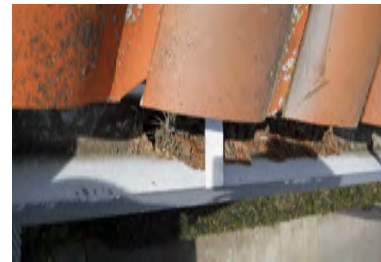
Typical Deficiency - Gutters are full of debris. Recommend clearing debris from all gutters, drains, waterways, and field of roof to promote positive drainage.
