Mountain View Whisman School District Roof Assessment

Edith Landels ES
115 West Dana St.
Mountain View, CA 94041

Prepared By:
Western Roofing Service
15002 Wicks Blvd.
San Leandro, CA 94577

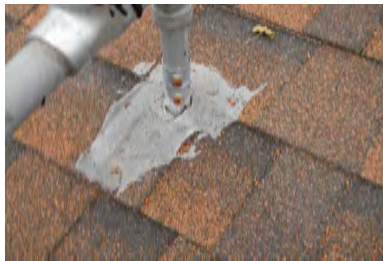
Typical Deficiency - Through roof penetrations do not appear to have proper roof jack. Recommend installing proper roof jack and storm collar.

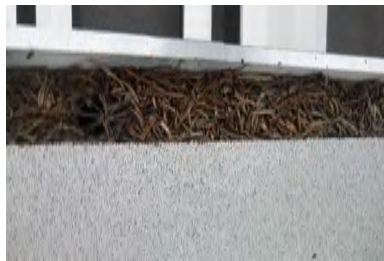
Typical Deficiency - Gutters are full of debris. Recommend clearing debris from all gutters, drains, waterways, and field of roof to promote positive drainage.

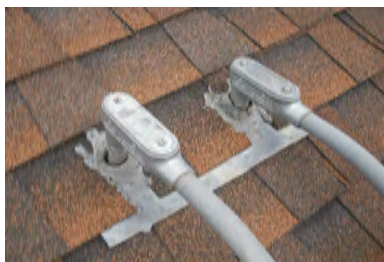
Typical Deficiency - Through roof penetrations do not appear to have proper roof jack. Recommend installing proper roof jack and storm collar.

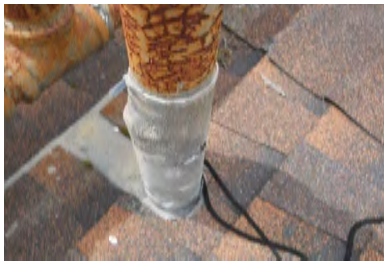
Typical Deficiency - Pipe jacks are missing band clamps and sealant. Recommend installing stainless steel band clamps, apply sealant, and install storm collar.

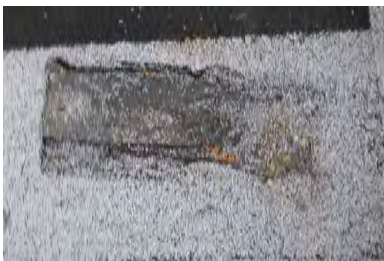
Typical Deficiency - Mineral surfaced cap sheet is damaged from previous sleeper block that has been removed. Recommend repairing as needed.

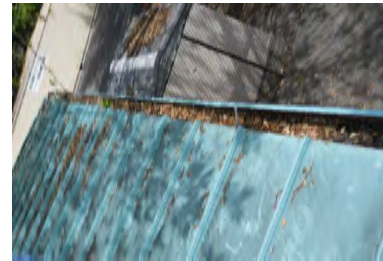
Typical Deficiency - Gutters are full of debris. Recommend clearing debris from all gutters, drains, waterways, and field of roof to promote positive drainage.

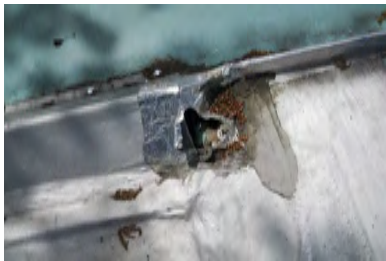
Typical Deficiency - Roof transition is open. Recommend removal of all temporary repairs and installation of as needed permanent repairs.

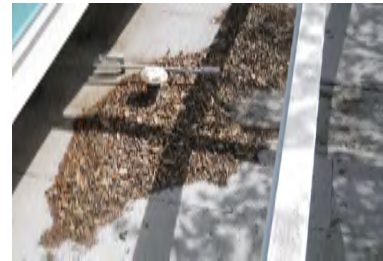
Typical Deficiency - Debris have accumulated at field of roof. Recommend clearing debris from all gutters, drains, waterways, and field of roof to promote positive drainage.

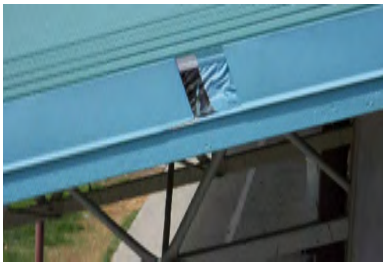
Typical Deficiency - Metal fascia detail is incomplete. Recommend repairing as necessary to provide a water tight application.

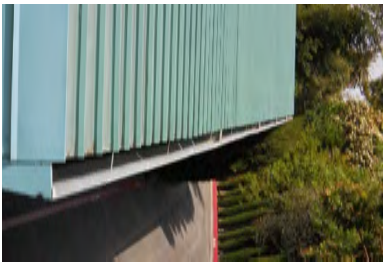
Typical Deficiency - Gutters are full of debris. Recommend clearing debris from all gutters, drains, waterways, and field of roof to promote positive drainage.

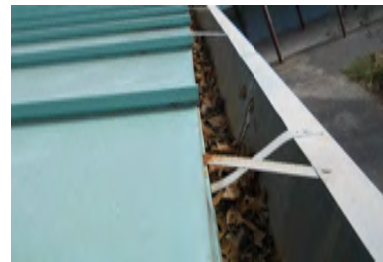
Typical Deficiency - Gutters are full of debris. Recommend clearing debris from all gutters, drains, waterways, and field of roof to promote positive drainage.

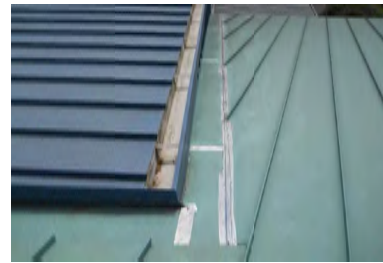
Typical Deficiency - Roof transition/ cricket has been temporarily sealed. Recommend removal of all temporary repairs and installation of as needed permanent repairs.

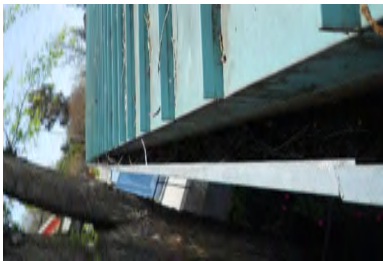
Typical Deficiency - Gutters are full of debris. Recommend clearing debris from all gutters, drains, waterways, and field of roof to promote positive drainage.

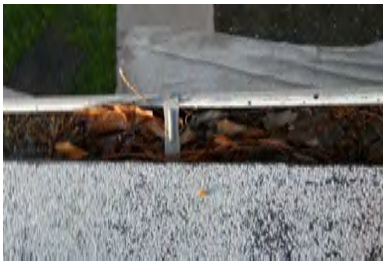
Typical Deficiency - Gutters are full of debris. Recommend clearing debris from all gutters, drains, waterways, and field of roof to promote positive drainage.

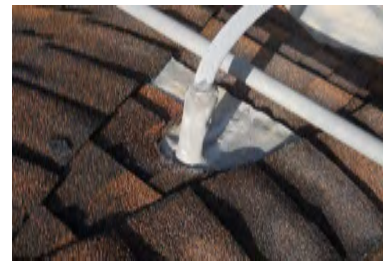
Typical Deficiency - Pipe jacks are missing band clamps and sealant. Recommend installing stainless steel band clamps, apply sealant, and install storm collar.

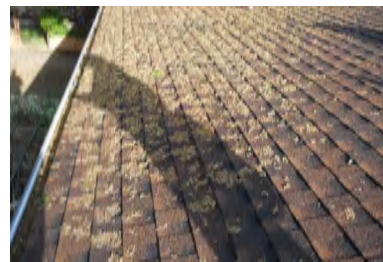
Typical Deficiency - Gutters are full of debris. Recommend clearing debris from all gutters, drains, waterways, and field of roof to promote positive drainage.

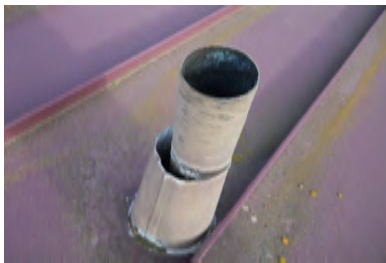
Typical Deficiency - Pipe jacks are missing sealant. Recommend application of flexible flashing self-adhered tape and or sealant, and install storm collar.

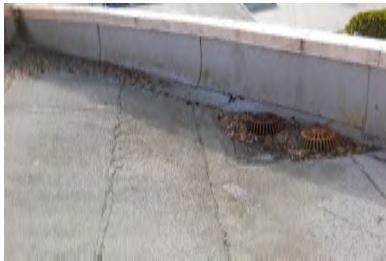
Typical Deficiency - Debris have accumulated at field of roof. Recommend clearing debris from all gutters, drains, waterways, and field of roof to promote positive drainage.

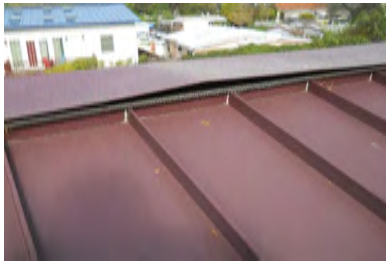
Typical Deficiency - Ridge cap has buckled. Recommend removal and reinstallation incorporating an expansion plate for movement.

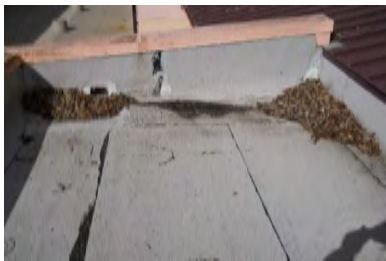
Typical Deficiency - Debris have accumulated at field of roof. Recommend clearing debris from all gutters, drains, waterways, and field of roof to promote positive drainage. Through wall scuppers should have debris screens. Recommend installation of gutter screens to promote positive drainage.

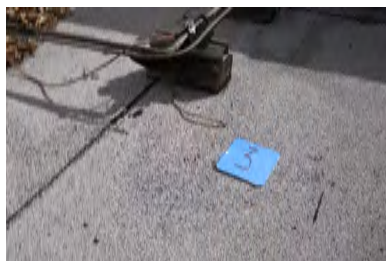
Typical Deficiency - Mineral surfaced cap sheet has blistered. Recommend relief cutting blister, imbed in layer of modified mastic, and apply target sheet of mineral surfaced cap sheet in cold applied adhesive.

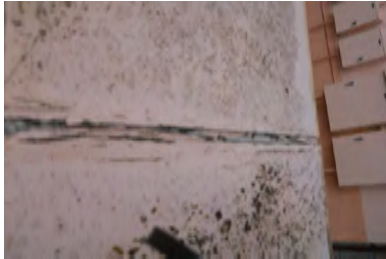
Typical Deficiency - Sealant at coping seams has begun to fail. Recommend removal and replacement of sealant as needed.

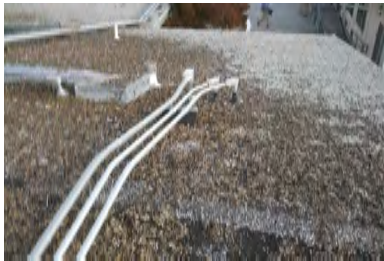
Typical Deficiency - Debris have accumulated at field of roof. Recommend clearing debris from all gutters, drains, waterways, and field of roof to promote positive drainage.

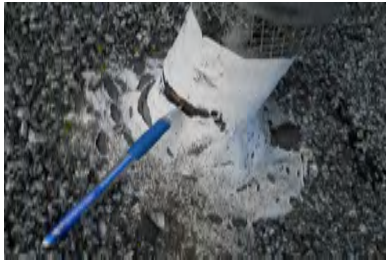
Typical Deficiency - Detailing at through roof penetrations show signs of cracking and delamination. Recommend touch up of mastic at penetrations and application of acrylic or silicone coating to preserve and maintain repair.

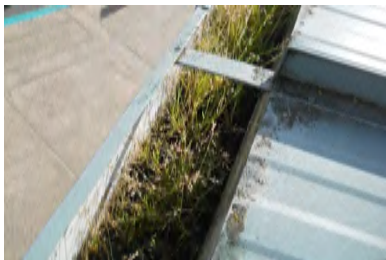
Typical Deficiency - Gutters are full of debris. Recommend clearing debris from all gutters, drains, waterways, and field of roof to promote positive drainage.
