**Mountain View
Whisman
School District**

ROOF ASSESSMENTS

Western Roofing Service

Benjamin Bubbs ES
 525 Hans Ave.
 Mountain View, CA 94040

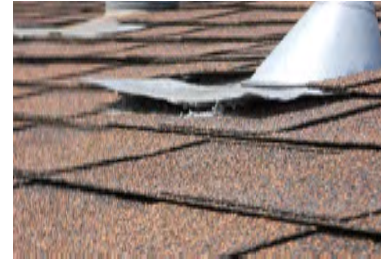
Typical Deficiency - Pipe jacks are damaged. Recommend installing new GSM roof jack and storm collar.

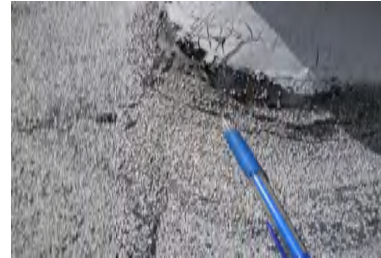
Typical Deficiency - Detailing at through roof penetrations show signs of cracking and delamination. Recommend touch up of mastic at penetrations and application of acrylic or silicone coating to preserve and maintain repair.

Touch up of mastic at penetrations and apply acrylic or silicone coating to preserve repair.

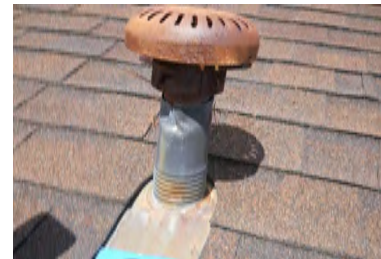
Typical Deficiency - Pipe jacks are missing band clamps and sealant. Recommend installing stainless steel band clamps, apply sealant, and install storm collar.

Install stainless steel band clamps and storm collars as needed.

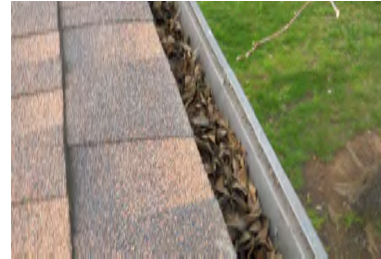
Typical Deficiency - Gutters are full of debris. Recommend clearing debris from all gutters, drains, waterways, and field of roof to promote positive drainage.

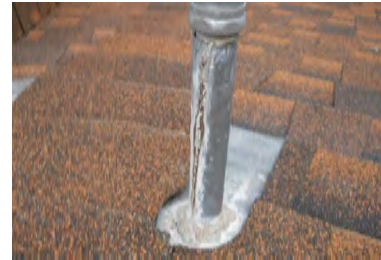
Typical Deficiency - Pipe jacks are missing band clamps and sealant. Recommend installing stainless steel band clamps, apply sealant, and install storm collar.

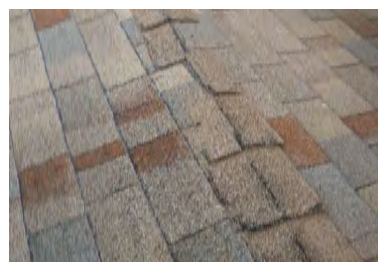
Typical Deficiency - Hip and ridge shingles are damaged and missing. Recommend replacing as needed.

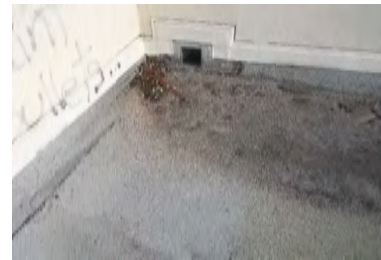
Typical Deficiency - Through wall scuppers should have debris screens. Recommend installation of gutter screens to promote positive drainage.

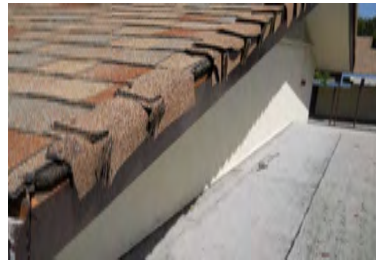
Typical Deficiency - Hip and ridge shingles are damaged and missing. Recommend replacing as needed.

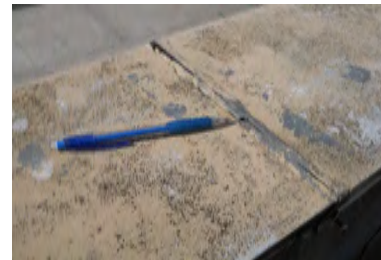
Typical Deficiency - Sealant at coping seams has begun to fail. Recommend removal and replacement of sealant as needed.

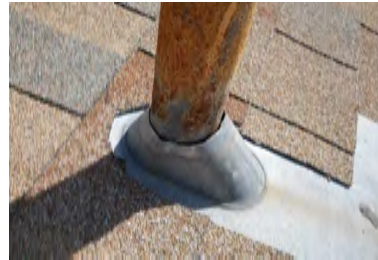
Typical Deficiency - Pipe jacks are missing sealant. Recommend application of flexible flashing self-adhered tape and or sealant, and install storm collar.

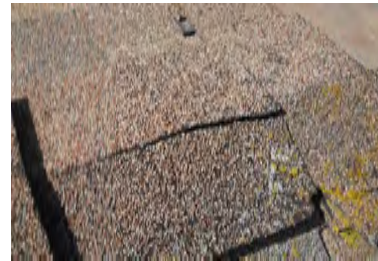
Typical Deficiency - Hip and ridge shingles are damaged and missing. Recommend replacing as needed.

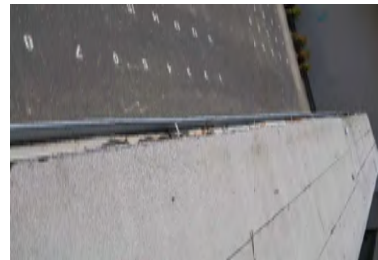
Typical Deficiency - Gutters are full of debris. Recommend clearing debris from all gutters, drains, waterways, and field of roof to promote positive drainage.

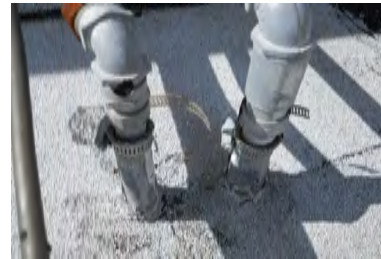
Typical Deficiency - Pipe jacks are missing sealant. Recommend application of flexible flashing self-adhered tape and or sealant, and install storm collar.

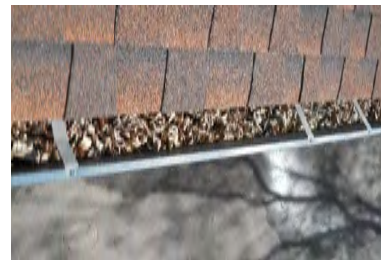
Typical Deficiency - Gutters are full of debris. Recommend clearing debris from all gutters, drains, waterways, and field of roof to promote positive drainage.

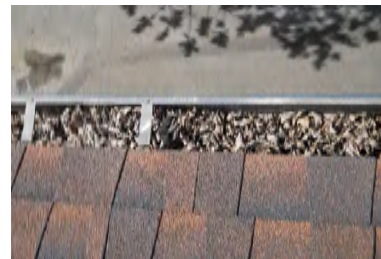
Typical Deficiency - Gutters are full of debris. Recommend clearing debris from all gutters, drains, waterways, and field of roof to promote positive drainage.

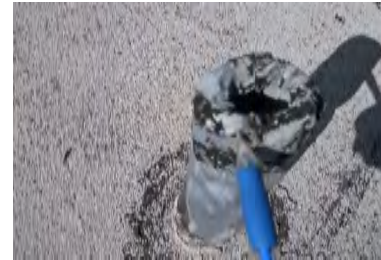
Typical Deficiency - Pipe jacks are missing sealant. Recommend application of flexible flashing self-adhered tape and or sealant, and install storm collar.

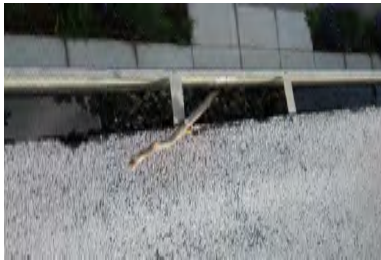
Typical Deficiency - Gutters are full of debris. Recommend clearing debris from all gutters, drains, waterways, and field of roof to promote positive drainage.

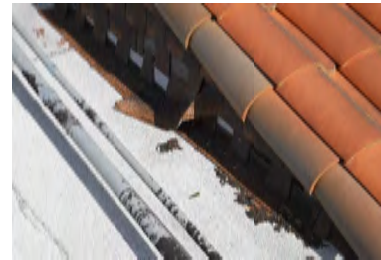
Typical Deficiency - Roof to wall transition has been improperly detailed. Recommend removing shingles and installing proper counterflashing assembly, roofing and wall finishes by others.

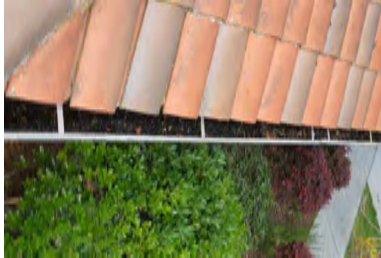
Typical Deficiency - Gutters are full of debris. Recommend clearing debris from all gutters, drains, waterways, and field of roof to promote positive drainage.

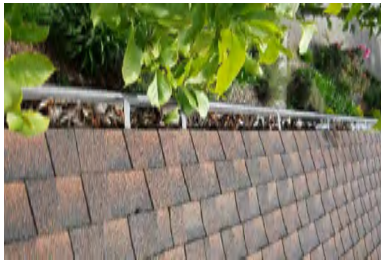
Typical Deficiency - Gutters are full of debris. Recommend clearing debris from all gutters, drains, waterways, and field of roof to promote positive drainage.

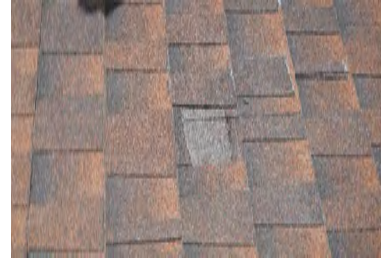
Typical Deficiency - Asphalt shingles are damaged and missing. Recommend replacing as needed.

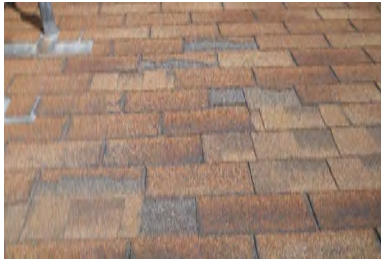
Typical Deficiency - Asphalt shingles are damaged and missing. Recommend replacing as needed.

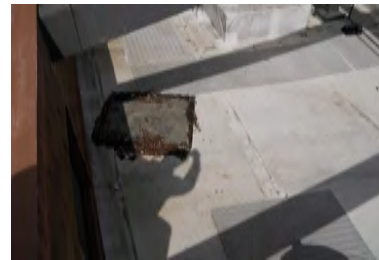
Typical Deficiency - Observed accumulation of debris at field of roof. Recommend clearing debris from all gutters, drains, waterways, and field of roof to promote positive drainage.

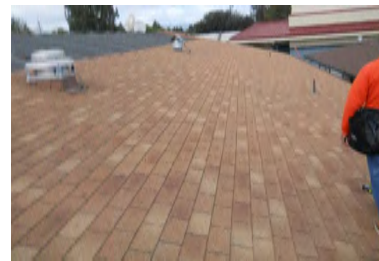
Typical Deficiency - Observed fastener penetrating through finished asphalt shingle roofing. Recommend removal and repair as needed.
