# Mountain View Whisman School District

## Roof Assessment

**Edith Landels ES**  
 115 West Dana St.  
 Mountain View, CA 94041

**Prepared By:**  
 Western Roofing Service  
 15002 Wicks Blvd.  
 San Leandro, CA 94577

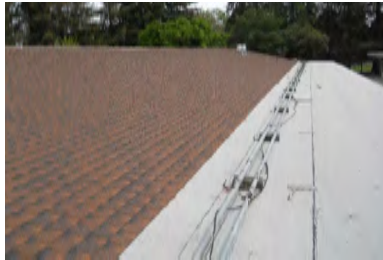
Roof Overview - Building 1&2

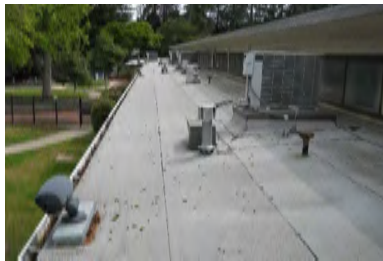
Roof Overview - Building 1&2

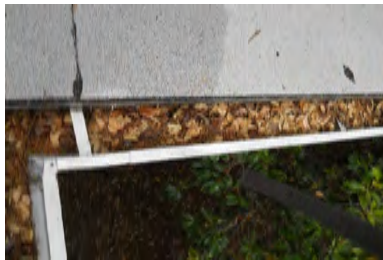
Typical Deficiency - Gutters are full of debris. Recommend clearing debris from all gutters, drains, waterways, and field of roof to promote positive drainage.

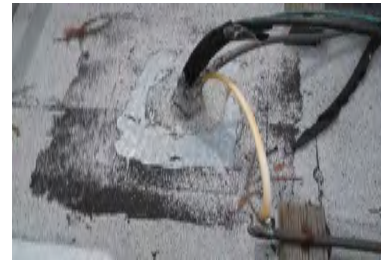
Typical Deficiency - Condenser line sets and electrical have not been flashed properly. Recommend installing galvanized pitch pocket with cover.

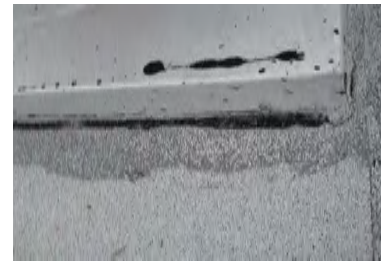
Typical Deficiency - Corner detailing at mechanical curb penetrations show signs of cracking and delamination. Recommend touch up of mastic and application of acrylic or silicone coating to preserve and maintain repair.

Blistering of mineral surfaced cap sheet. Cracking and delamination of mastics at base flashing curb penetrations. Cracking and shrinking of pitch pocket sealants at roof penetrations.

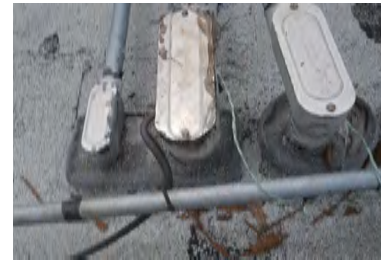
Typical Deficiency - LB electrical penetrations have not been flashed properly. Recommend installing galvanized pitch pocket with cover.

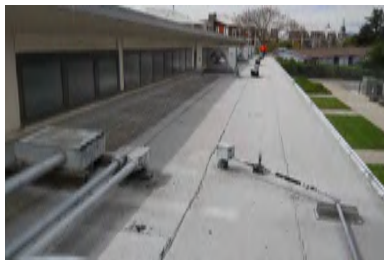
Roof Overview - Building 3

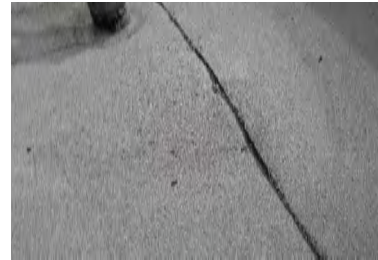
Typical Deficiency - Mineral surfaced cap sheet has blistered. Recommend relief cutting blister, imbed in layer of modified mastic, and apply target sheet of mineral surfaced cap sheet in cold applied adhesive.

Repair blisters at mineral surfaced cap sheet as needed.

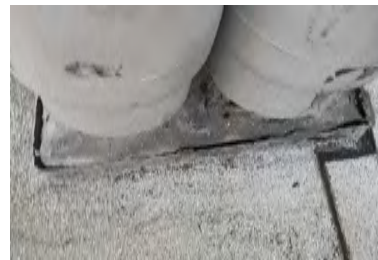
Typical Deficiency - Pitch pocket sealants have dried out and pulled away from flashing. Recommend topping off pitch pocket with compatible sealer or modified mastic and application of acrylic or silicone coating to preserve and maintain repair.

Top off pitch pockets with modified mastic or compatible sealants as needed, coat with acrylic or silicone coating to preserve repair.

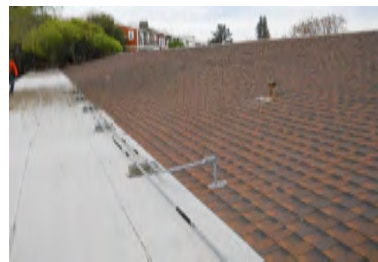
Roof Overview - Building 4

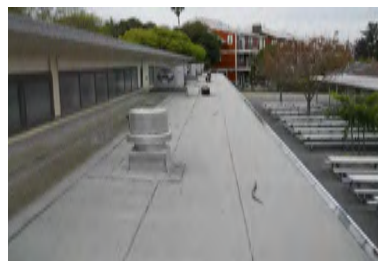
Roof Overview - Building 4

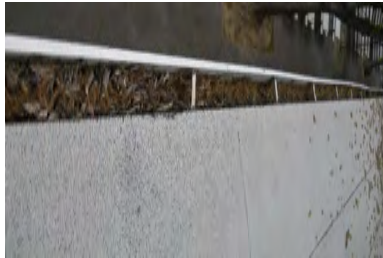
Typical Deficiency - Gutters are full of debris. Recommend clearing debris from all gutters, drains, waterways, and field of roof to promote positive drainage.

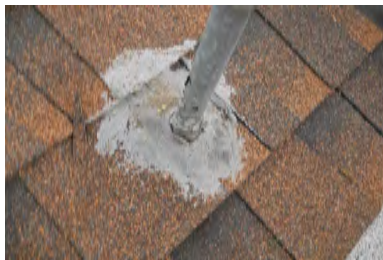
Typical Deficiency - Through roof penetrations do not appear to have proper roof jack. Recommend installing proper roof jack and storm collar.

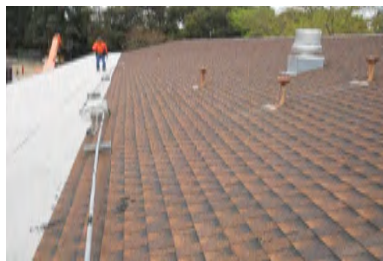
Roof Overview - Building 5

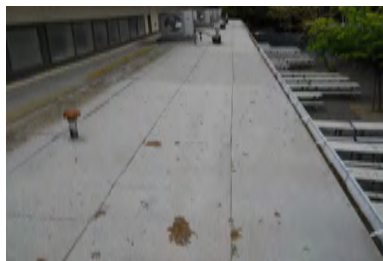
Roof Overview - Building 5

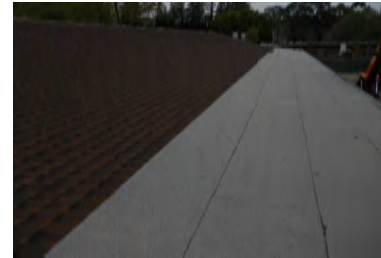
Roof Overview - Building 5

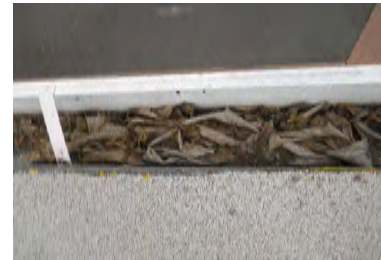
Typical Deficiency - Gutters are full of debris. Recommend clearing debris from all gutters, drains, waterways, and field of roof to promote positive drainage.

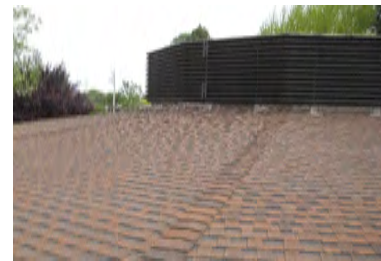
Roof Overview - Building 6

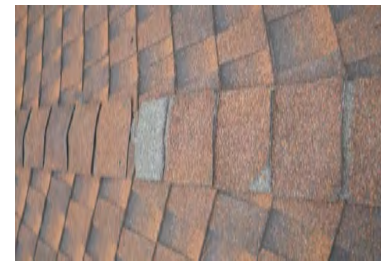
Typical Deficiency - Hip and ridge shingles are missing. Recommend replacing as needed.

Replace missing shingles as needed.

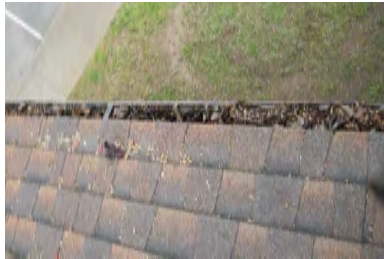
Typical Deficiency - Gutters are full of debris. Recommend clearing debris from all gutters, drains, waterways, and field of roof to promote positive drainage.

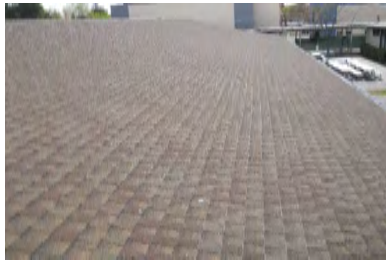
Roof Overview - Building H

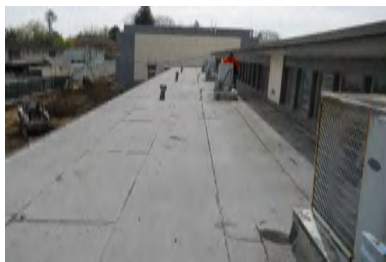
Roof Overview - Building H

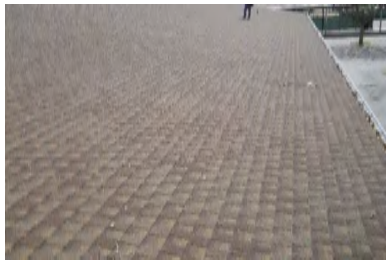
Roof Overview - Building J

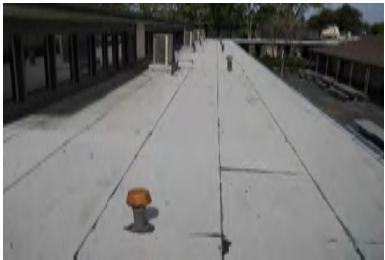
Roof Overview - Building J

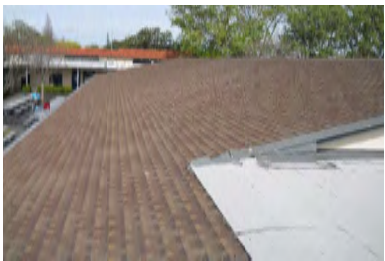
Roof Overview - Building K

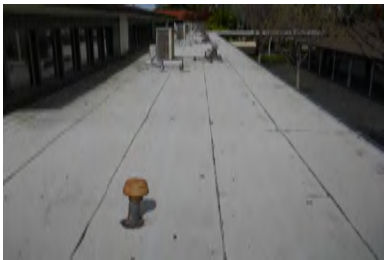
Roof Overview - Building K

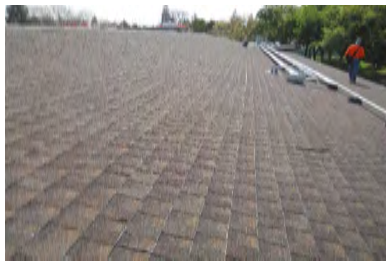
Roof Overview - Building L

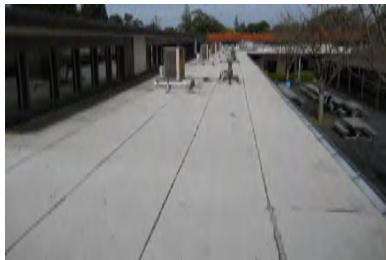
Roof Overview - Building L

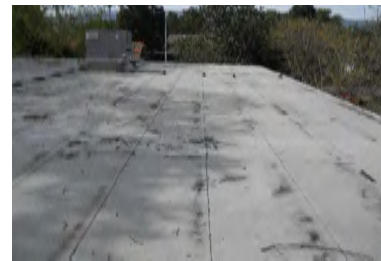
Roof Overview - Building M

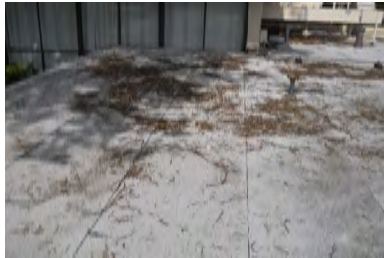
Typical Deficiency - Observed debris at field of roofing. Recommend clearing debris from all gutters, drains, waterways, and field of roof to promote positive drainage.

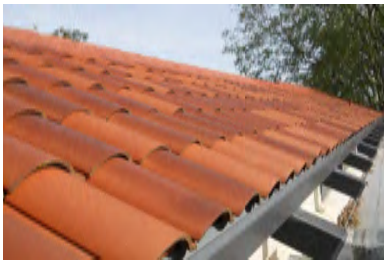
Roof Overview - Building N

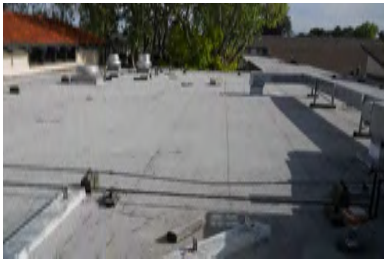
Roof Overview - Building N

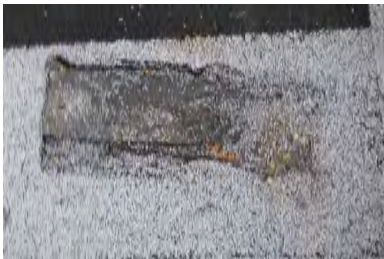
Typical Deficiency - Mineral surfaced cap sheet is damaged from previous sleeper block that has been removed. Recommend repairing as needed.

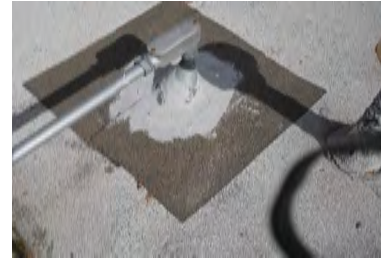
Typical Deficiency - Through roof penetrations has not been properly flashed. Recommend installing new roof jack and storm collar.

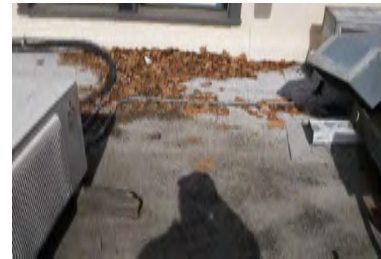
Typical Deficiency - Observed debris at field of roofing. Recommend clearing debris from all gutters, drains, waterways, and field of roof to promote positive drainage.

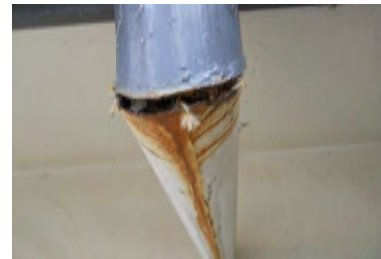
Typical Deficiency - Leader pipe seam is broken. Recommend repairing and or replacement.

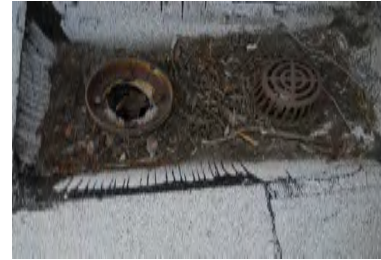
Typical Deficiency - Observed debris at field of roofing. Recommend clearing debris from all gutters, drains, waterways, and field of roof to promote positive drainage.

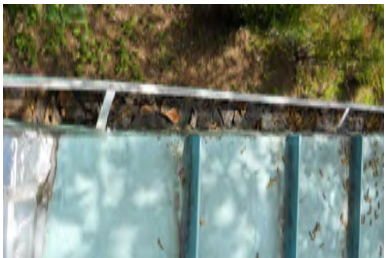
Typical Deficiency - Gutters are full of debris.  
Recommend clearing debris from all gutters, drains, waterways, and field of roof to promote positive drainage.

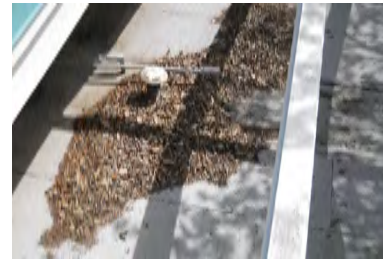
Typical Deficiency - Debris have accumulated at field of roof. Recommend clearing debris from all gutters, drains, waterways, and field of roof to promote positive drainage.

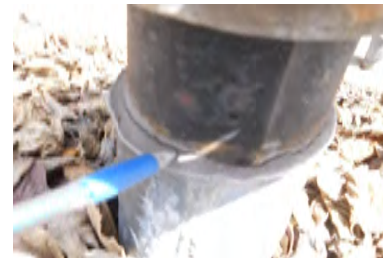
Typical Deficiency - Lead pipe jacks are missing band clamps and sealant.  
Recommend installing stainless steel band clamps, apply sealant, and install storm collar.

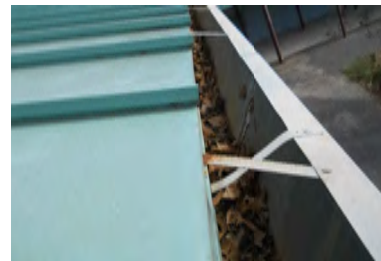
Typical Deficiency - Gutters are full of debris. Recommend clearing debris from all gutters, drains, waterways, and field of roof to promote positive drainage.

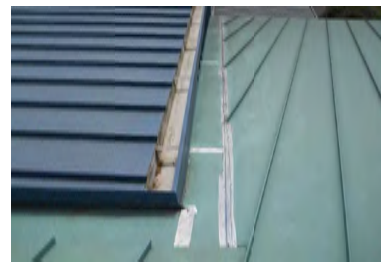
Typical Deficiency - Roof transition/ cricket has been temporarily sealed. Recommend removal of all temporary repairs and installation of as needed permanent repairs.

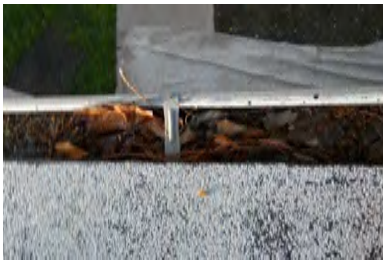
Typical Deficiency - Gutters are full of debris. Recommend clearing debris from all gutters, drains, waterways, and field of roof to promote positive drainage.

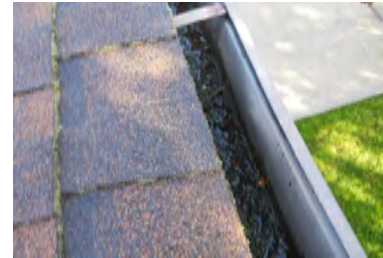
Typical Deficiency - Gutters are full of debris. Recommend clearing debris from all gutters, drains, waterways, and field of roof to promote positive drainage.

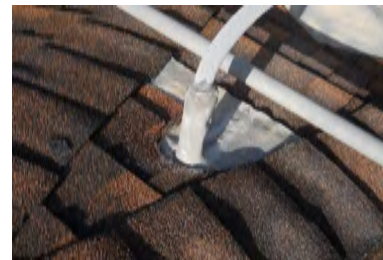
Typical Deficiency - Pipe jacks are missing band clamps and sealant. Recommend installing stainless steel band clamps, apply sealant, and install storm collar.

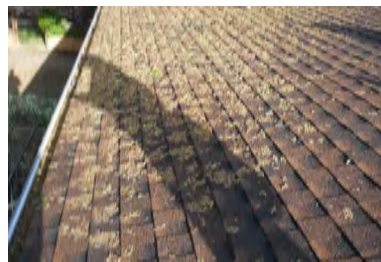
Typical Deficiency - Gutters are full of debris. Recommend clearing debris from all gutters, drains, waterways, and field of roof to promote positive drainage.

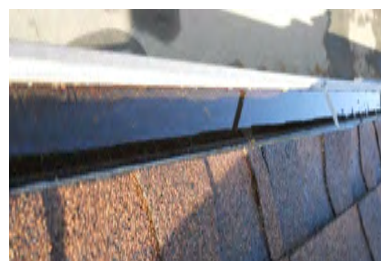
Typical Deficiency - Gutters are full of debris. Recommend clearing debris from all gutters, drains, waterways, and field of roof to promote positive drainage.

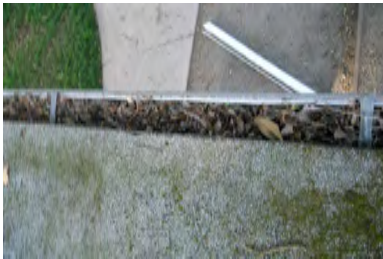
Typical Deficiency - Gutters are full of debris. Recommend clearing debris from all gutters, drains, waterways, and field of roof to promote positive drainage.

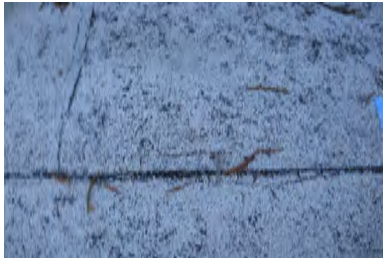
Typical Deficiency - Blister between BUR plies. Recommend relieving blister, dry moisture, imbed ply in modified mastic, and apply sacrificial protection membrane in cold adhesive.

Remove all debris from field of roof, drain assemblies, gutters, and waterways.  
Repair blistered membrane.

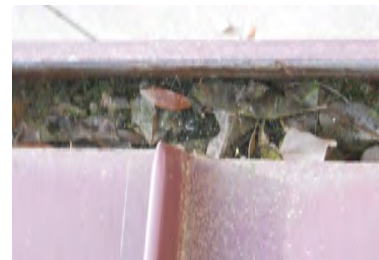
Typical Deficiency - Gutters are full of debris. Recommend clearing debris from all gutters, drains, waterways, and field of roof to promote positive drainage.

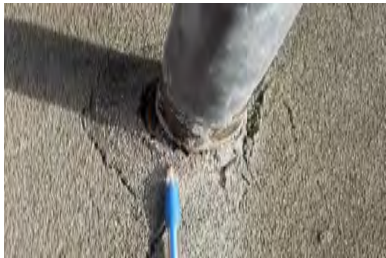
Typical Deficiency - Detailing at through roof penetrations show signs of cracking and delamination. Recommend touch up of mastic at penetrations and application of acrylic or silicone coating to preserve and maintain repair.

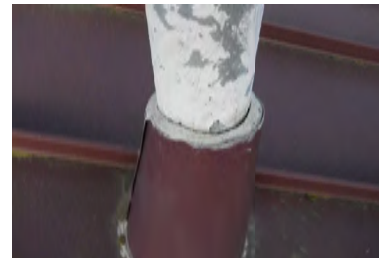
Typical Deficiency - Pipe jacks are missing sealant. Recommend application of flexible flashing self-adhered tape and or sealant, and install storm collar.

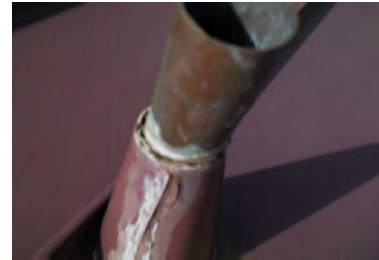
Typical Deficiency - Pipe jacks are missing sealant. Recommend application of flexible flashing self-adhered tape and or sealant, and install storm collar.

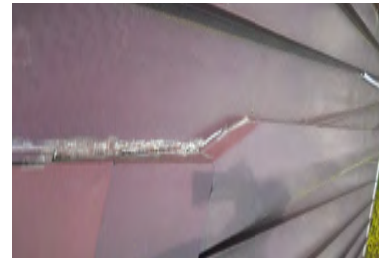
Typical Deficiency - Roof transition/ cricket has been temporarily sealed. Recommend removal of all temporary repairs and installation of as needed permanent repairs.

Repair metal transitions, ridge cap, and gutter as needed.

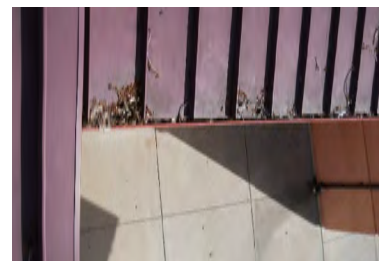
Typical Deficiency - Gutters are full of debris. Recommend clearing debris from all gutters, drains, waterways, and field of roof to promote positive drainage.

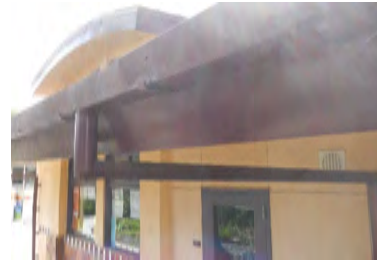
Typical Deficiency - Damaged gutter. Recommend repair as needed.

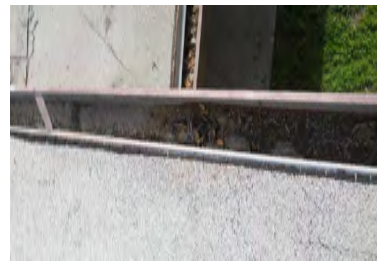
Typical Deficiency - Gutters are full of debris. Recommend clearing debris from all gutters, drains, waterways, and field of roof to promote positive drainage.

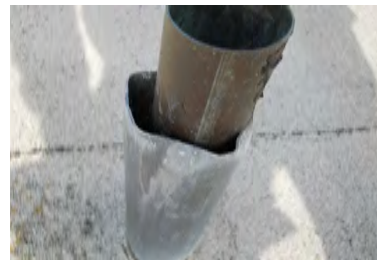
Typical Deficiency - Pipe jacks are missing sealant. Recommend application of flexible flashing self-adhered tape and or sealant, and install storm collar.

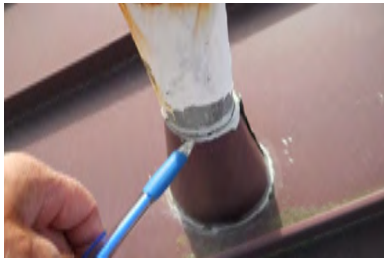
Typical Deficiency - Pipe jacks are missing sealant. Recommend application of flexible flashing self-adhered tape and or sealant, and install storm collar.

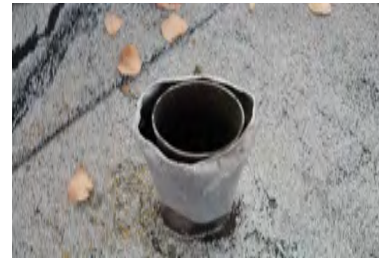
Typical Deficiency - Pipe jacks are missing sealant. Recommend application of flexible flashing self-adhered tape and or sealant, and install storm collar.

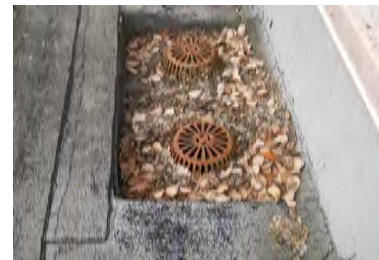
Typical Deficiency - Debris have accumulated at field of roof. Recommend clearing debris from all gutters, drains, waterways, and field of roof to promote positive drainage.

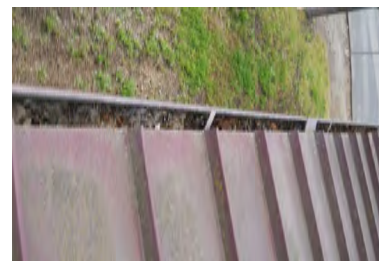
Typical Deficiency - Gutters are full of debris. Recommend clearing debris from all gutters, drains, waterways, and field of roof to promote positive drainage.

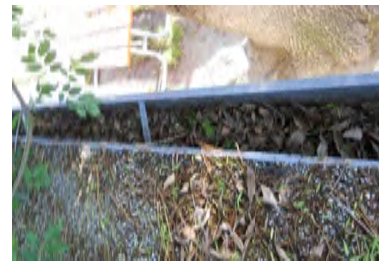
Typical Deficiency - Gutters are full of debris. Recommend clearing debris from all gutters, drains, waterways, and field of roof to promote positive drainage.

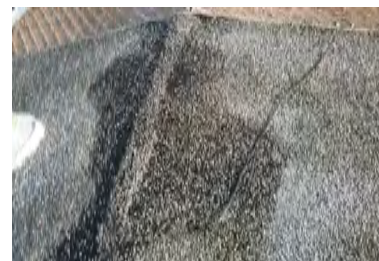
Typical Deficiency - Areas of displaced gravel. Recommend re-distributing and adhering gravel over bare areas to protect underlying membrane from exposure to UV .

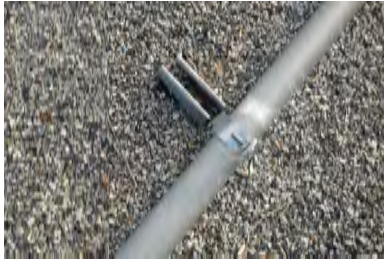
Typical Deficiency - Unistrut supports have been fastened directly through existing roof system. Recommend removal, repair of roof and refastening support to sleeper, floating block, etc..

Remove incorrectly roof mounted conduits and remount correctly, repair roofing as needed.

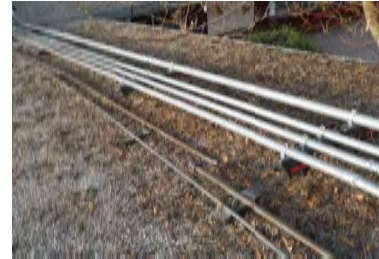
Typical Deficiency - Debris have accumulated at field of roof. Recommend clearing debris from all gutters, drains, waterways, and field of roof to promote positive drainage.

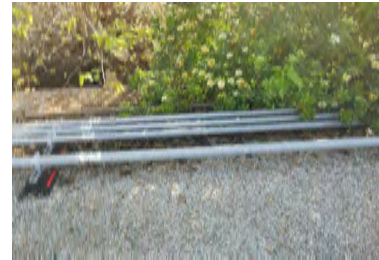
Typical Deficiency - Debris have accumulated at field of roof. Recommend trimming trees back from roof eaves, clearing debris from all gutters, drains, waterways, and field of roof to promote positive drainage.

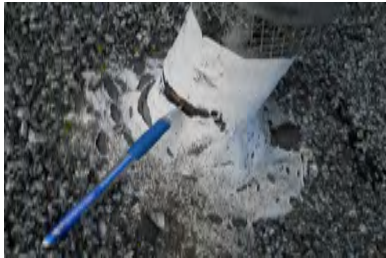
Typical Deficiency - Detailing at through roof penetrations show signs of cracking and delamination. Recommend touch up of mastic at penetrations and application of acrylic or silicone coating to preserve and maintain repair.

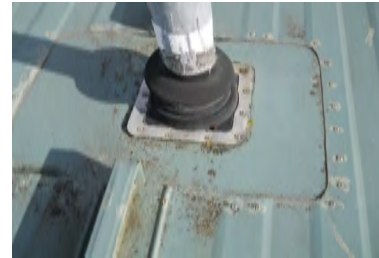
Typical Deficiency - Detailing at through roof penetrations show signs of cracking and delamination. Recommend touch up of sealants..

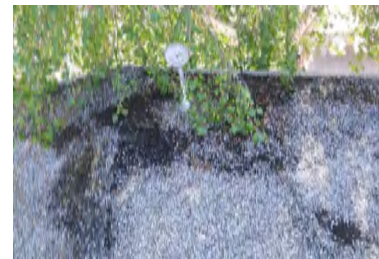
Typical Deficiency - Areas of displaced gravel. Recommend re-distributing and adhering gravel over bare areas to protect underlying membrane from exposure to UV .
