**Mountain View
Whisman
School District**

ROOF ASSESSMENTS

Western Roofing Service

Mountain View Whisman School District Roof Assessment

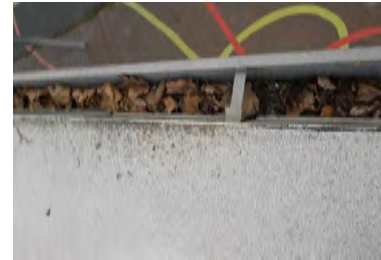
Typical Deficiency - Gutters are full of debris. Recommend clearing debris from all gutters, drains, waterways, and field of roof to promote positive drainage.

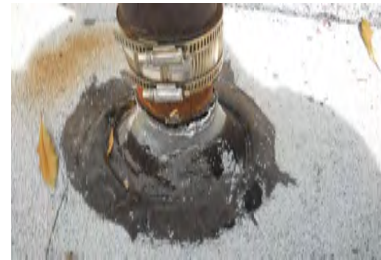
Typical Deficiency - Through roof penetrations do not appear to have proper low slope roof jack. Recommend installing proper roof jack and storm collar.

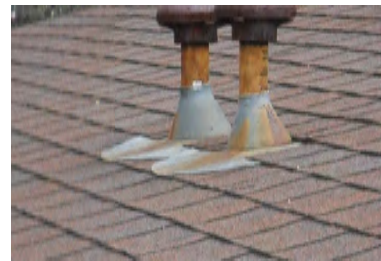
Typical Deficiency - Pipe jacks are missing band clamps and sealant. Recommend installing stainless steel band clamps, sealant, and install storm collar.

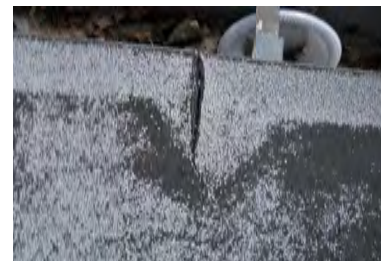
Typical Deficiency - BUR at gravel stop edge metal has split at joints. Recommend removing loose material to expose adequate tie-in of existing striping plies, prime and re-flash per industry standards.

Repair splits in mineral surfaced cap sheet at gravel stop.

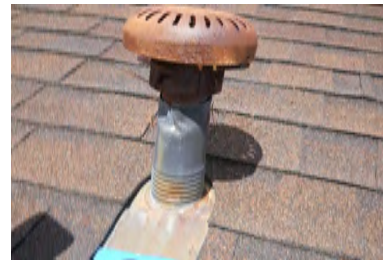
Typical Deficiency - Pipe jacks are missing band clamps and sealant. Recommend installing stainless steel band clamps, apply sealant, and install storm collar.

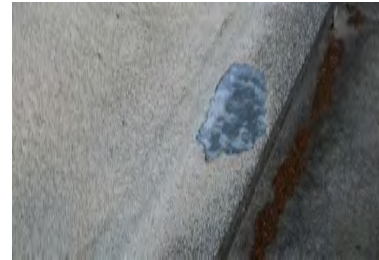
Typical Deficiency - Coating has begun to delaminate from perimeter coping cap. Recommend touch up as needed.

Repair damaged coating.

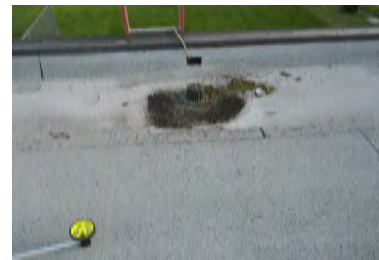
Typical Deficiency - Debris have accumulated at field of roof. Recommend clearing debris from all gutters, drains, waterways, and field of roof to promote positive drainage.

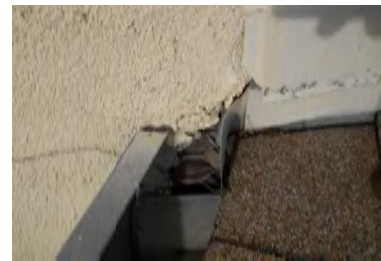
Typical Deficiency - Observed exposed lath and underlayment at roof to wall transition. Recommend stucco patch and as needed sealing to protect underlayment and minimize water intrusion behind stucco.

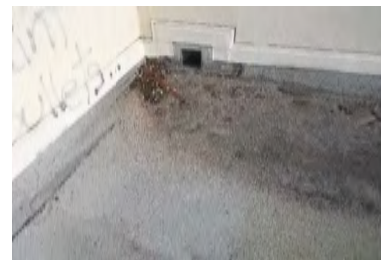
Typical Deficiency - Through wall scuppers should have debris screens. Recommend installation of gutter screens to promote positive drainage.

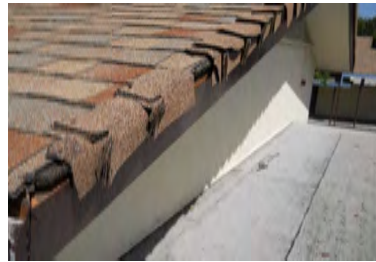
Typical Deficiency - Hip and ridge shingles are damaged and missing. Recommend replacing as needed.

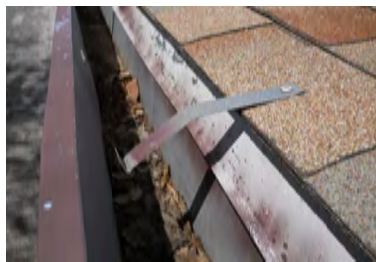
Typical Deficiency - Gutter brackets have been face fastened through asphalt shingle. Recommend removal and repositioning bracket. Repair asphalt shingles as needed.

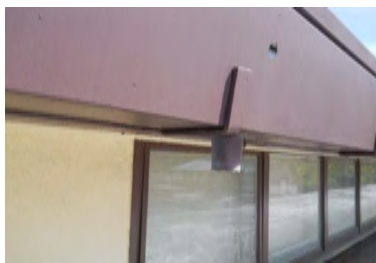
Typical Deficiency - Missing leader pipe. Recommend installation of leader pipe to divert water to lower roof.

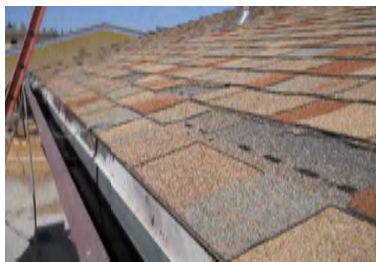
Typical Deficiency - Asphalt shingles are damaged and missing. Recommend replacing as needed.

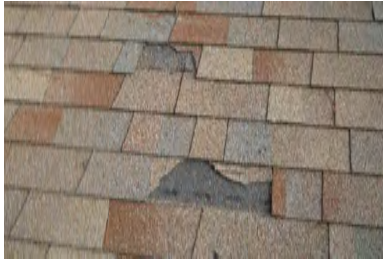
Typical Deficiency - Asphalt shingles are damaged and missing. Recommend replacing as needed.

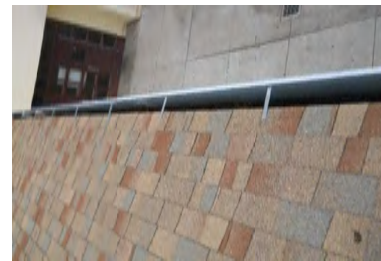
Typical Deficiency - Gutter brackets have been face fastened through asphalt shingle. Recommend removal and repositioning bracket. Repair asphalt shingles as needed.

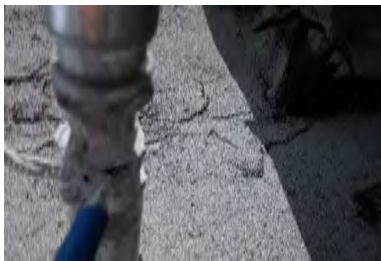
Typical Deficiency - Pipe jacks are missing sealant. Recommend application of flexible flashing self-adhered tape and or sealant, and install storm collar.

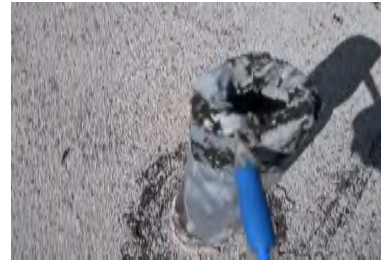
Typical Deficiency - Pipe jacks are missing sealant. Recommend application of flexible flashing self-adhered tape and or sealant, and install storm collar.

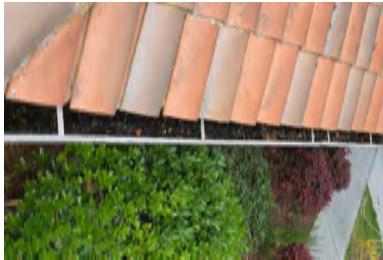
Typical Deficiency - Gutters are full of debris. Recommend clearing debris from all gutters, drains, waterways, and field of roof to promote positive drainage.

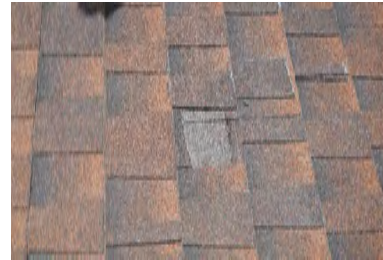
Typical Deficiency - Asphalt shingles are damaged and missing. Recommend replacing as needed.

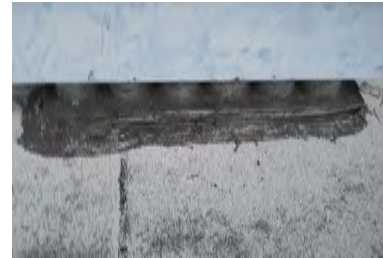
Typical Deficiency - Pitch pockets have dried up and sealant has pulled away from galvanized sheet metal flashing. Recommend removal and replacement of sealants.

Top off pitch pockets with modified mastic or compatible sealants as needed, coat with acrylic or silicone coating to preserve repair.

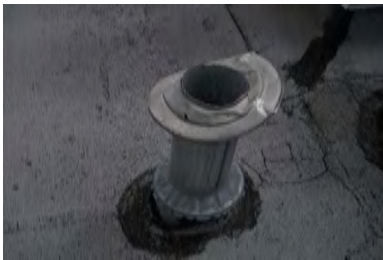
Typical Deficiency - Vent pipe is missing diffuser/ rain cap. Recommend installing rain cap and or replacement of vent.

Installing missing rain cap at vent pipes as needed.

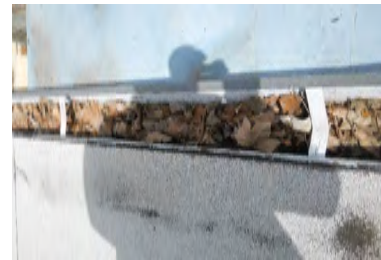
Typical Deficiency - Gutters are full of debris. Recommend clearing debris from all gutters, drains, waterways, and field of roof to promote positive drainage.
