Mountain View Whisman School District Roof Assessment

Edith Landels ES
115 West Dana St.
Mountain View, CA 94041

Prepared By:
Western Roofing Service
15002 Wicks Blvd.
San Leandro, CA 94577

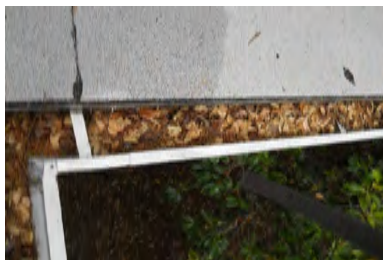
Typical Deficiency - Gutters are full of debris. Recommend clearing debris from all gutters, drains, waterways, and field of roof to promote positive drainage.

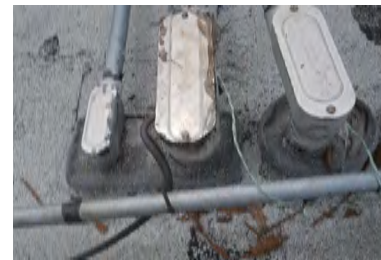
Typical Deficiency - LB electrical penetrations have not been flashed properly. Recommend installing galvanized pitch pocket with cover.

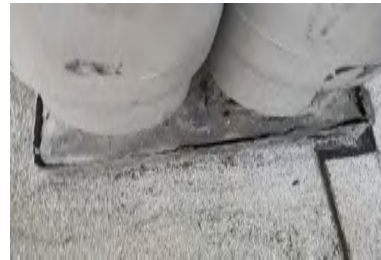
Typical Deficiency - Pitch pocket sealants have dried out and pulled away from flashing. Recommend topping off pitch pocket with compatible sealer or modified mastic and application of acrylic or silicone coating to preserve and maintain repair.

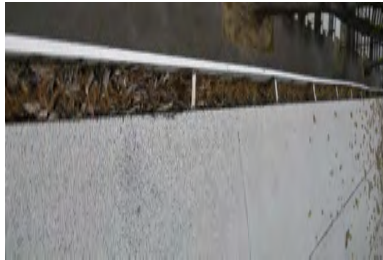
Typical Deficiency - Gutters are full of debris. Recommend clearing debris from all gutters, drains, waterways, and field of roof to promote positive drainage.

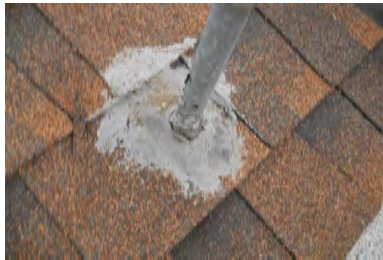
Typical Deficiency - Through roof penetrations do not appear to have proper roof jack. Recommend installing proper roof jack and storm collar.

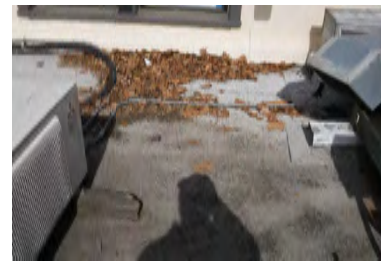
Typical Deficiency - Observed debris at field of roofing. Recommend clearing debris from all gutters, drains, waterways, and field of roof to promote positive drainage.

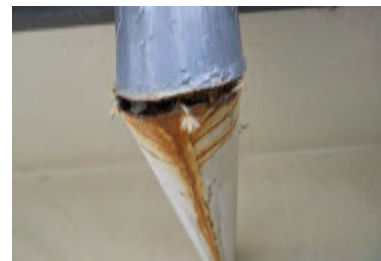
Typical Deficiency - Leader pipe seam is broken. Recommend repairing and or replacement.

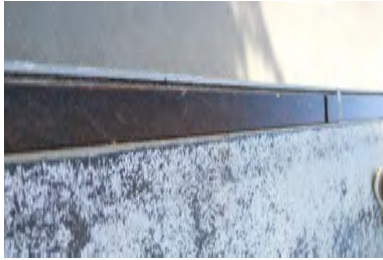
Typical Deficiency - Gutters are full of debris. Recommend clearing debris from all gutters, drains, waterways, and field of roof to promote positive drainage.

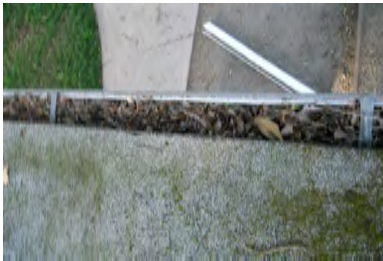
Typical Deficiency - Gutters are full of debris. Recommend clearing debris from all gutters, drains, waterways, and field of roof to promote positive drainage.

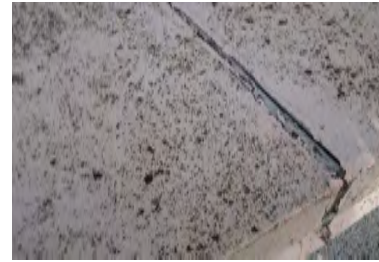
Typical Deficiency - Sealant at coping seams has begun to fail. Recommend removal and replacement of sealant as needed.

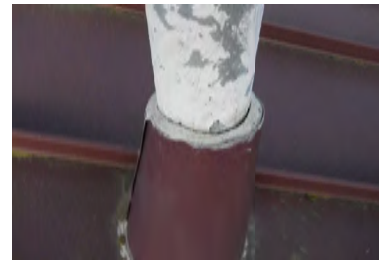
Typical Deficiency - Pipe jacks are missing sealant. Recommend application of flexible flashing self-adhered tape and or sealant, and install storm collar.

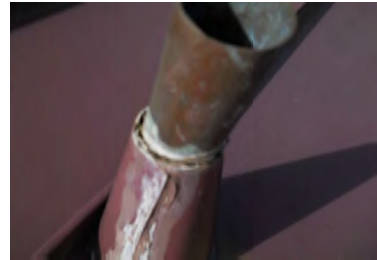
Typical Deficiency - Pipe jacks are missing sealant. Recommend application of flexible flashing self-adhered tape and or sealant, and install storm collar.

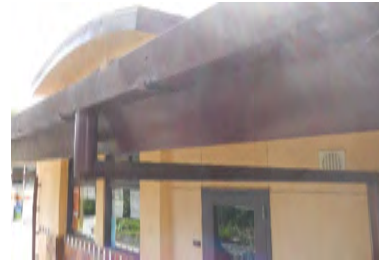
Typical Deficiency - Damaged gutter. Recommend repair as needed.

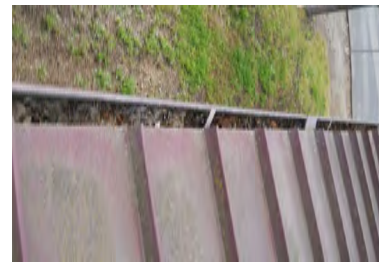
Typical Deficiency - Gutters are full of debris. Recommend clearing debris from all gutters, drains, waterways, and field of roof to promote positive drainage.

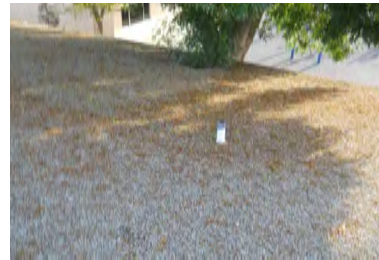
Typical Deficiency - Debris have accumulated at field of roof. Recommend clearing debris from all gutters, drains, waterways, and field of roof to promote positive drainage.

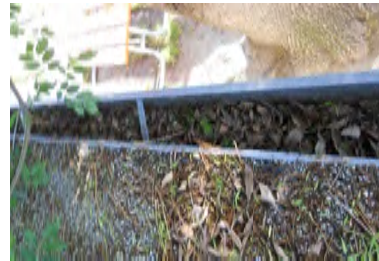
Typical Deficiency - Gutters are full of debris. Recommend clearing debris from all gutters, drains, waterways, and field of roof to promote positive drainage.

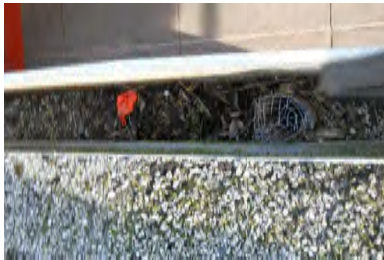
Typical Deficiency - Gutters are full of debris. Recommend clearing debris from all gutters, drains, waterways, and field of roof to promote positive drainage.

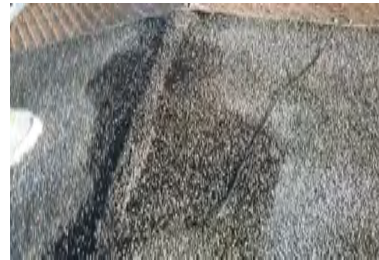
Typical Deficiency - Areas of displaced gravel. Recommend re-distributing and adhering gravel over bare areas to protect underlying membrane from exposure to UV .

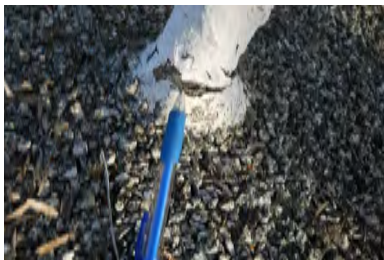
Typical Deficiency - Detailing at through roof penetrations show signs of cracking and delamination. Recommend touch up of mastic at penetrations and application of acrylic or silicone coating to preserve and maintain repair.

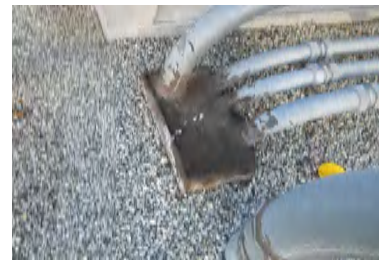
Typical Deficiency - Pitch pocket sealants have dried out and pulled away from flashing. Recommend topping off pitch pocket with compatible sealer or modified mastic and application of acrylic or silicone coating to preserve and maintain repair.

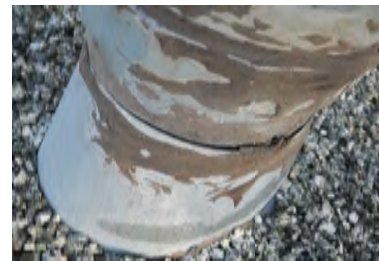
Typical Deficiency - Detailing at through roof penetrations show signs of cracking and delamination. Recommend touch up of mastic at penetrations and application of acrylic or silicone coating to preserve and maintain repair.

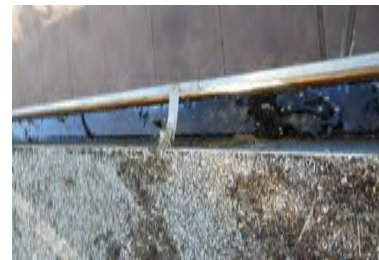
Typical Deficiency - Gutters are full of debris. Recommend clearing debris from all gutters, drains, waterways, and field of roof to promote positive drainage.

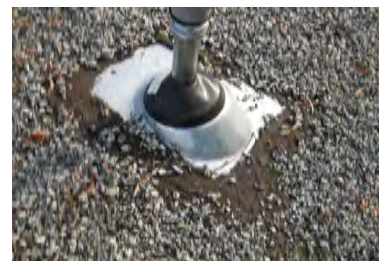
Typical Deficiency - Through roof penetrations do not appear to have proper roof jack. Recommend installing proper roof jack and storm collar.

Remove and replace incorrect roof jacks.

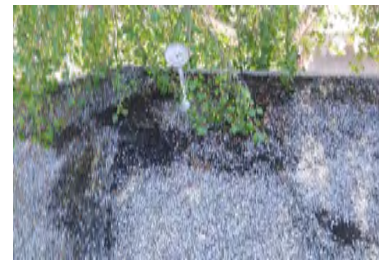
Typical Deficiency - Areas of displaced gravel. Recommend re-distributing and adhering gravel over bare areas to protect underlying membrane from exposure to UV .
